A Type Overdrive, Part I - Theory

Overview: The A type overdrive (OD) unit described here was manufactured by Laycock-de-Normanville and was a factory option on the TR2, TR3, TR4, TR5/250 and TR6 Triumphs through 1972. The function of the OD is to change the overall reduction ratio between the engine and rear wheels. It operates in two modes, the direct drive mode where there is no change in reduction ratio and the OD engaged mode where OD provides a 22% rpm increase in the output over the input rpm (i.e. overdriven). This means that for a given engine rpm, the road speed is 22% greater when the OD is engaged. Another way of saying this is that when the OD is engaged, the engine rpm is reduced by 18% for a given road speed. The OD is operator controlled via an electrical switch on the dash or steering column, depending on the model. The OD could be engaged only in 4th gear in the early TR2 application. The operation was changed after TR2 s/n TS5980 so that it could be engaged in the top three gears.

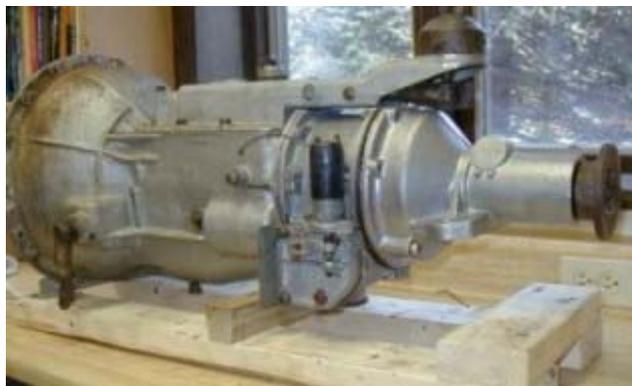
The OD unit is attached to the rear of a regular gearbox in place of the rear extension as shown on the right. The only changes required to the basic gearbox to use an overdrive (OD) are a different mainshaft and the addition of switches in the gearbox cover.

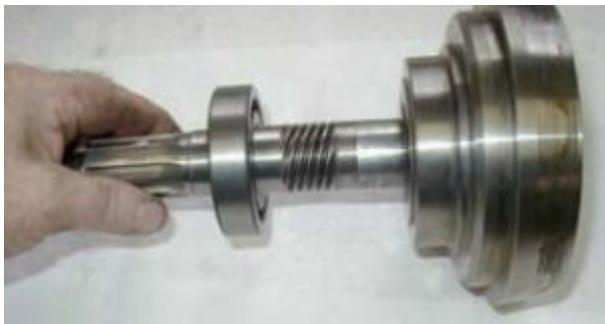
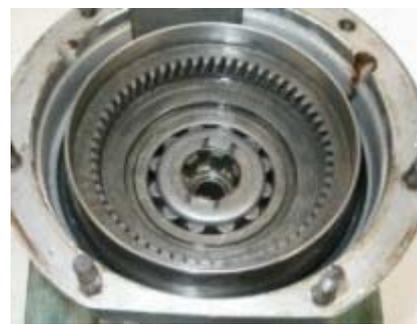
The photos below show the annulus. (Unless noted otherwise, all photos are of a TR3 OD unit, model #22/1374.) The output flange slides over the splines on the left side of the left photo. The spirals milled in the center of the shaft drive the speedometer gear. The shaft has two bearings, one over the splines and the other next to the shoulder on the right side of the shaft. The bearing on the shaft is in position to be pressed pass the spirals to the shoulder. The right photo shows the large end of the annulus with the ring gear. The annulus is still installed in the rear casting here. The rollers in the center are part of the unidirectional clutch discussed later.

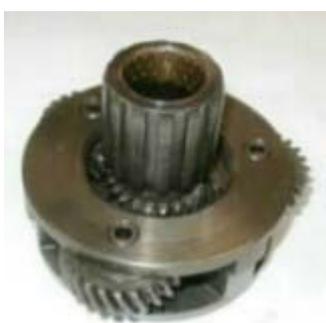
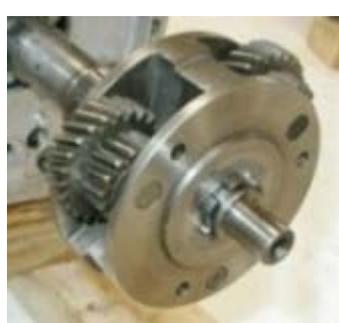
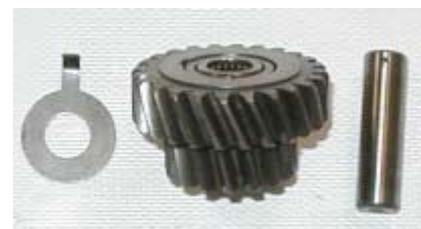
The epicyclic gear without the ring gear (annulus) is shown below. The left photo shows the sun gear in position. The middle photo shows the gears on the mainshaft. The splines on the inside of the planet gear carrier mate with the mainshaft so that input power is always applied via the planet gear carrier. The right photo shows one of the planet gears removed from the carrier. These gears are composed of two gears locked together and have two roller bearing cages pressed inside. The shaft the gears revolve on is pressed into the planet carrier. The washer with the tab is a thrust washer.

The number of the teeth on each of the gears is as follows:

- Sun gear = 21 teeth
- Larger planet gear = 24 teeth
- Smaller planet gear = 15 teeth
- Ring gear in annulus = 60 teeth.

When the planet carrier rotates one revolution, the larger planet gear rotates around the fixed sun gear once and will have passed all the 21 teeth on the sun gear. Since the planet gear has 24 teeth, it will have rotated $21/24 = .875$ revolution. The smaller planet gear meshes with the ring gear. The smaller planet gear also rotates .875 revolution when the planet carrier does one revolution, but since it has only 15 teeth, the total number of teeth meshed with the ring gear per revolution of the planet carrier is $.875 \times 15 = 13.125$ teeth. The amount the 60 tooth ring gear rotates due to the one planet gear rotation is $13.125/60 = .21875$ revolution. This is added to the one revolution caused by the planet carrier rotating with the planet gears not rotating giving a total of 1.21875 or rounded to 1.22. This means that when the OD is engaged, the road speed for a given RPM is 1.22 times the direct drive road speed. Another way to say it is that the engine RPM with the OD engaged for given road speed is $1/1.22 = .82$ times the direct drive RPM. (Randall Young suggested that other applications of these ODs such as the big Healeys use different ratios, some as low as 0.75 to 1.)

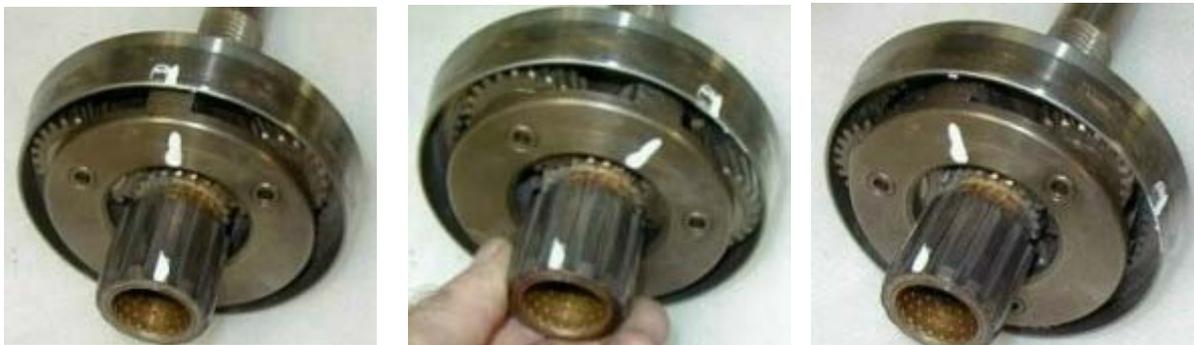
The three photos above show the assembled epicyclic gear. The left photo shows Whiteout marks on the sun gear shaft, on the planet gear carrier, and on the annulus. In the middle photo, the sun gear has been held stationary and the planet gear carrier has been rotated about 45 degrees clockwise. Note that the annulus seems to have rotated a bit further. The right photo shows the situation after the planet carrier has been rotated one full revolution with the sun gear held constant. Note that the annulus has rotated one full revolution plus nearly a further quarter revolution, exactly as computed above.

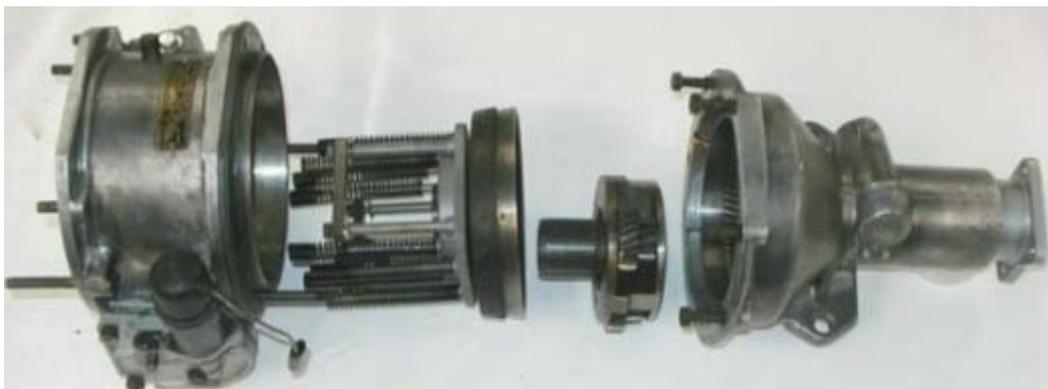
Case: The case is composed of two parts, the main casting and the rear casting. The main casting contains hydraulic components to switch the OD between the direct drive and overdrive. The rear casting contains the annulus & associated rear shaft bearings and speedometer gear. The photo below shows the main casting on the left, then the sliding clutch, then planet carrier with sun gear and planet gears then the rear casting with the annulus installed inside.

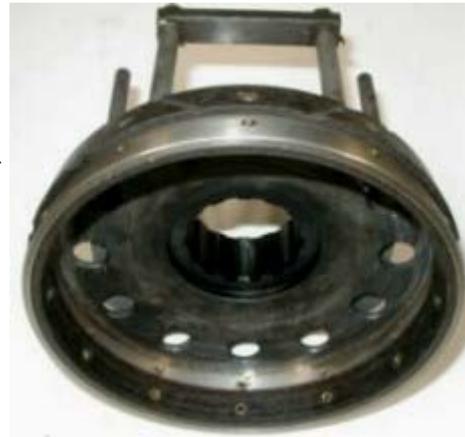
The photo at the right shows the end of the clutch sliding member. The thrust ring is to the rear. The clutch material is visible on the cone shaped outer and inner surfaces of the sliding member. There is a bearing (the thrust bearing) between the thrust ring and the sliding member that allow the sliding member to rotate. Splines are visible on the inside of the sliding member. These splines mate with similar splines on the sun gear shaft (see previous photos). Note that the thrust ring doesn't rotate. The sliding member rotates with the annulus when in direct drive and doesn't rotate in overdrive.

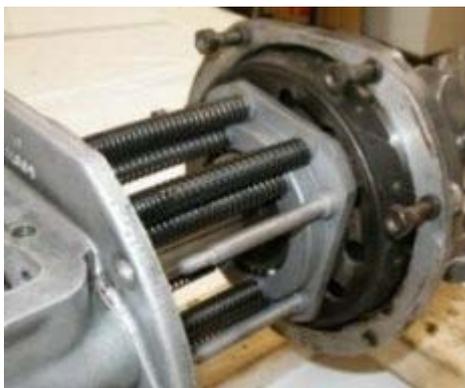
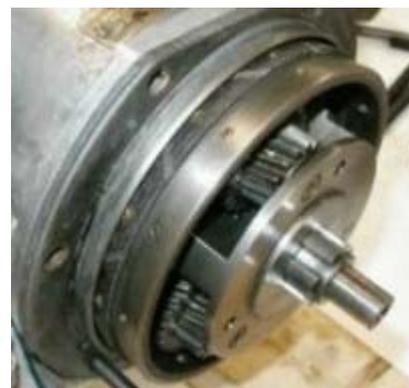
The thrust ring is pushed back by eight clutch release springs and via the bearing forces the sliding member onto the cone part of the annulus for direct drive. This is shown in the left photo below where the main casting has been removed. The thrust ring is pulled to the front by two hydraulic pistons when in OD. This in turn pulls the outside of the sliding member into the brake ring at the rear of the main casting. This is shown in the right photo below where the rear casting and annulus has been removed.

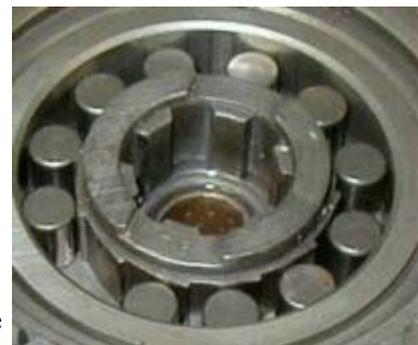
Unidirectional clutch: This clutch fits into a recess in the annulus as shown on the right. *The roller cage and one of the rollers has been removed to show how the clutch works.* The splines on the inside mate with the gearbox mainshaft. If the inside of this clutch (the mainshaft) tries to rotate faster in the clockwise direction than the annulus, the rollers will go up the little ramps and be forced against the annulus in turn forcing it to stay at the same speed as the mainshaft. Conversely, if the annulus is rotating faster in the clockwise direction that the center part, the rollers are forced down the ramp relieving the force against the annulus hence disengaging the clutch. In summary, for clockwise rotation, the output can rotate no slower than the input, but may rotate faster than the input.

For counterclockwise rotation, the opposite is true. If the annulus is rotating slower than the mainshaft, the rollers go down the ramps and the clutch is released. If the annulus tries to rotate faster than the mainshaft, the rollers go up the ramp and lock the annulus to the mainshaft

Now consider what would happen if the OD were to be engaged in reverse; the annulus will try to rotate 22% faster counterclockwise than the mainshaft. However, as stated previously, the unidirectional clutch prevents the annulus from rotating faster than the mainshaft in the counterclockwise direction. Lets say that again, the epicyclic gear is forcing the output to turn faster than the input while the unidirectional clutch is preventing the output from turning faster than the input. What happens? If we're lucky, the sliding clutch slips and the problem is discovered quickly and fixed. If we're unlucky, something breaks. The message: **THE OVERDRIVE MUST NOT BE ENGAGED IN REVERSE!**

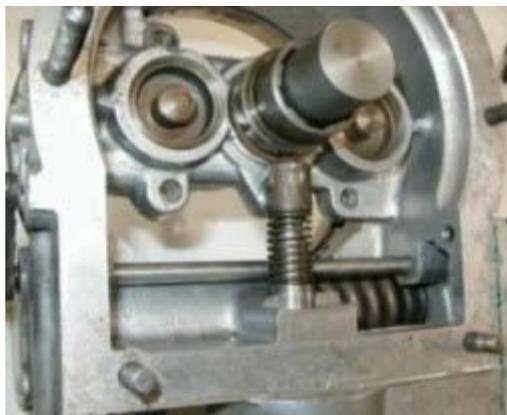
The Pump: The top photo on the right shows the front of the main casting. The vertical rod with the spring around it is the pump piston. The top of the piston is fitted with a roller to ride on a cam on the mainshaft. The heavy rod protruding from the cam is a dummy mainshaft. The round objects on each side the cam are the operating pistons discussed later. The large horizontal spring on the lower right of the photo is the outside accumulator spring, also discussed later.

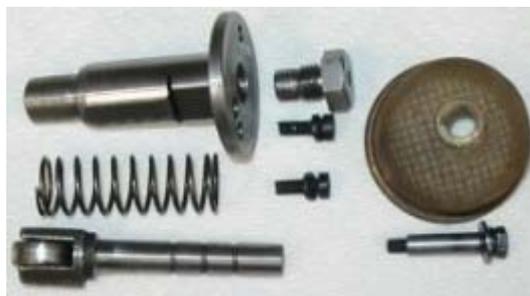
The second photo shows the pump components. The pump body is top left with spring and then piston below it. The pump body is pressed into the main casting and secured with the two screws. The spring is used to force the piston up --- the mainshaft cam forces it down. The lower end of the cylinder is sealed with the large threaded pump body plug in the upper middle. The screened cup is a filter secured to the plug by the screw in the lower right.

The diagram, taken from the Service Instruction Manual, shows the pump cross section. The piston is shown in the full down position, nearly touching the pump body plug. Oil is supplied from the screen filter at the bottom up through a milled flat section on the outside of the pump body and into the cylinder through a slit. The slit and flat section can be seen in the photo of the pump components.

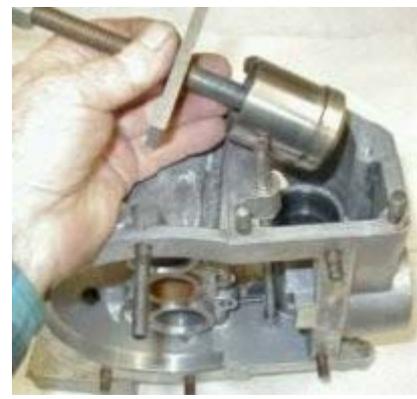
Accumulator: The early accumulator consists of a cylinder in the main casting fitted with a piston and held by a pair of springs. The top photo on the right shows the piston being extracted from the cylinder. The next photo shows the piston and the two heavy springs. The smaller spring fits inside the larger one.

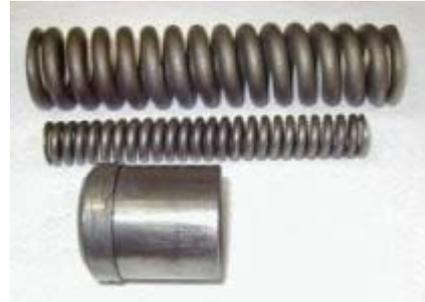
Oil from the pump goes through a passage in the main casting into the bottom of the accumulator cylinder. As oil is pumped in, the piston is pushed out of the cylinder compressing the two springs. The pressure builds as the springs are compressed.

There are a series of holes along the cylinder wall that connect to a passage to a chamber around the mainshaft for lubrication. The holes are exposed when accumulator is pushed past these holes, allowing fluid to escape from the accumulator. These holes are the pressure relief mechanism. The nominal pressure required to push the piston to the holes is 360 psi.

Before leaving the accumulator, a comparison of some of the properties is appropriate. The early accumulator uses a 1.75 inch diameter piston that moves about 0.8 inches to uncover the relief holes. The later accumulator uses a 1.125 inch radius piston that moves about 0.5 inches to uncover the relief holes. The force on the piston is the product of the piston cross sectional area times the hydraulic pressure.

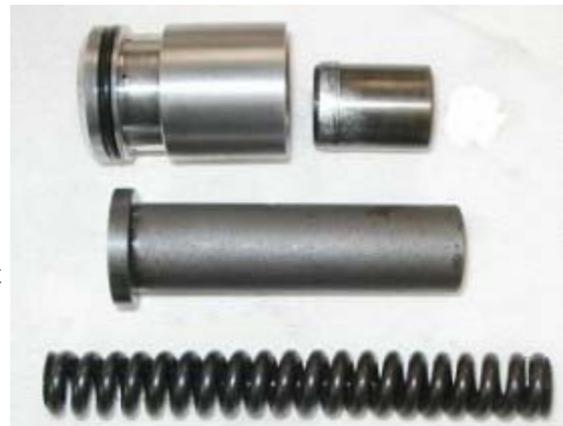
The later ODs (models #22/1753 & #22/1985) use a different accumulator as shown in photo on right. An "accumulator housing" (top left in the photo) slides into the cylinder in the casting in place of the piston in the early accumulator. A smaller piston (top right) fits in the housing. A spacing tube (middle of photo) holds the accumulator housing in position (otherwise, when fluid is pumped into the cylinder in the casting, the accumulator housing would be pushed out just like the piston in the earlier design). Pressure relief holes are located in the recess just to the right of the O ring, one of which is visible in the photo. A somewhat smaller spring is required to hold the force exerted by the smaller piston, even at the higher nominal pressure of 450 psi.

It is possible to replace the earlier accumulator with the later accumulator (the housing, piston, spacing tube and spring are all required). The Victoria British Catalog suggests this option if replacement springs, piston or rings are required for the early accumulator.

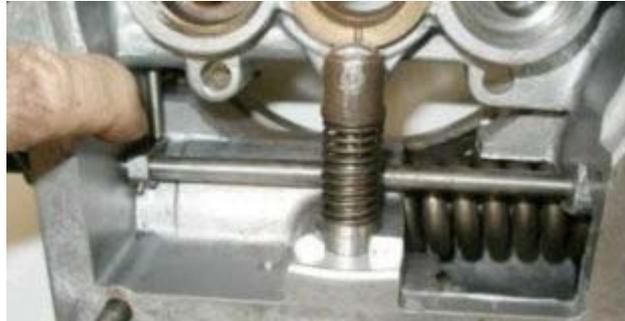
The lever (K above) is connected to a shaft that extends beyond the main casting on both sides. (See photo below where a finger is pointing to lever K with the operating valve J setting on the lever.) The solenoid rotates this shaft via a lever on the left side of the main casting (right side of the photo below).

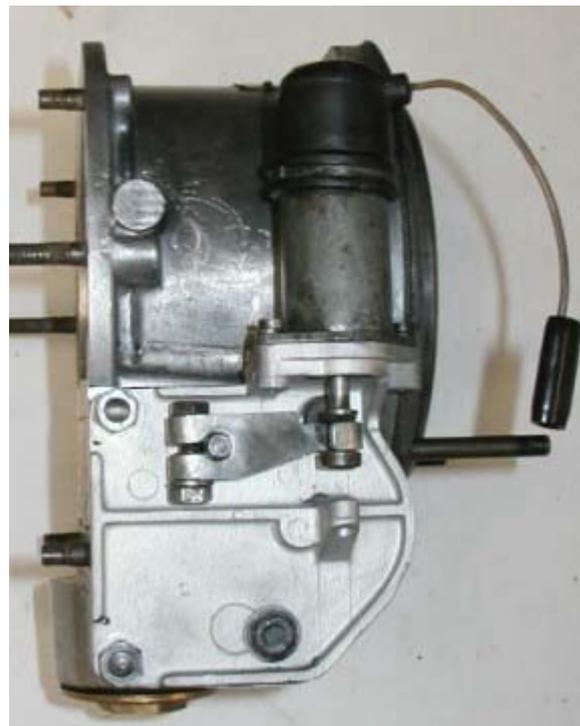
Solenoid: The solenoid is the cylinder with the wire coming out the top in the photo on the right. The rod extending from the bottom of the solenoid is called the plunger. The shaft end to the left of the plunger is the same shaft in the previous photo that controls the operating valve. The lever clamped to this shaft is called the actuating lever. When 12 volt power is applied to the solenoid (via the dangling wire) the plunger moves up, pulling the end of the actuating lever with it. This causes the shaft to rotate and via lever K pictured above, the operating valve to lift in turn engaging overdrive. When power is removed, the solenoid plunger drops allowing the operating valve to close and the unit to shift to direct drive.

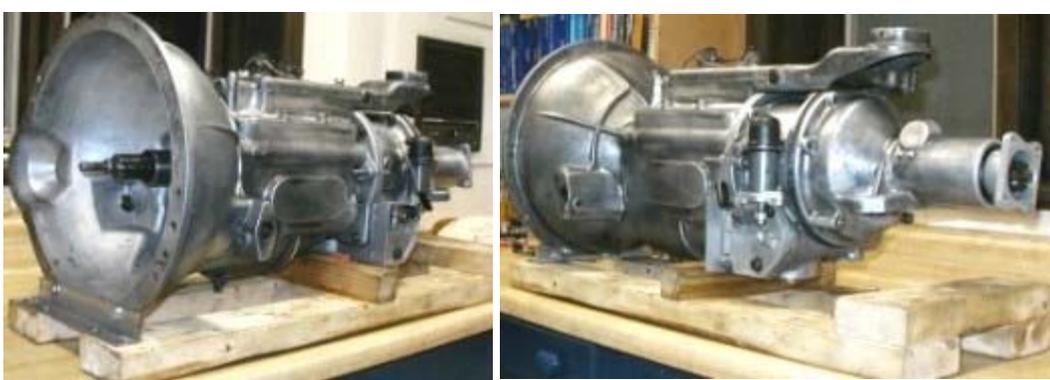
Gearbox Stand: I use a gearbox stand made from scrap pieces of 2X4, 2X2 and a short piece of steel angle as seen in the photos below. The gearbox bolts to the angle at the front. The 2X2 near the rear of the main gearbox casting has a shim tacked to the top to adjust the gearbox so that it is horizontal. The stand took about 30 minutes to make and proved its worth in about 15 minutes of use.

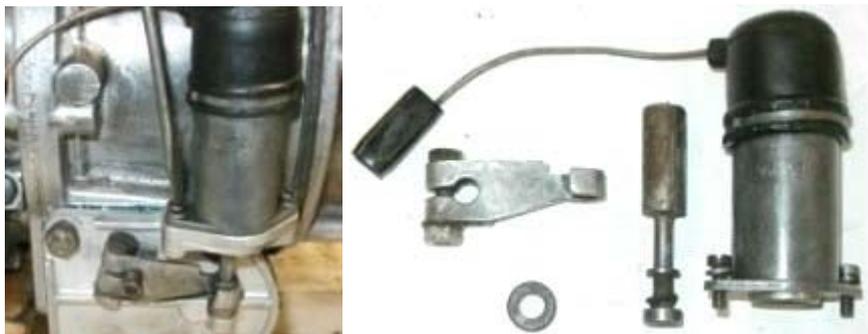
Remove the small parts: It's convenient to remove several small parts from the OD unit before detaching the OD from the gearbox, starting with the solenoid. The solenoid sticks up and makes a nice handle. Unfortunately, using it for a handle nearly always breaks the bracket to which it attaches. At ~ \$75 per bracket, an expensive handle. (That small aluminum casting is known both as the solenoid bracket and the cover plate. The term cover plate is used from here on.) It's best to get the solenoid off and in a protected place first thing. The following photos show the solenoid attachment screws being removed (left). The solenoid, plunger, actuating lever and collar are then removed. When new there was a rubber boot around the end of the solenoid to prevent debris from entering the cylinder in which the plunger slides. The boots have long since cracked and fell off on most these old units. Replacement boots are not available so we do without. I've operated several without boots for about 15 years with no problems.

As parts are removed they are thoroughly cleaned and inspected. To keep track of the parts, associated groups of parts are placed in small zip lock plastic bags. For example, the parts in the lower right photo were put in the same bag.

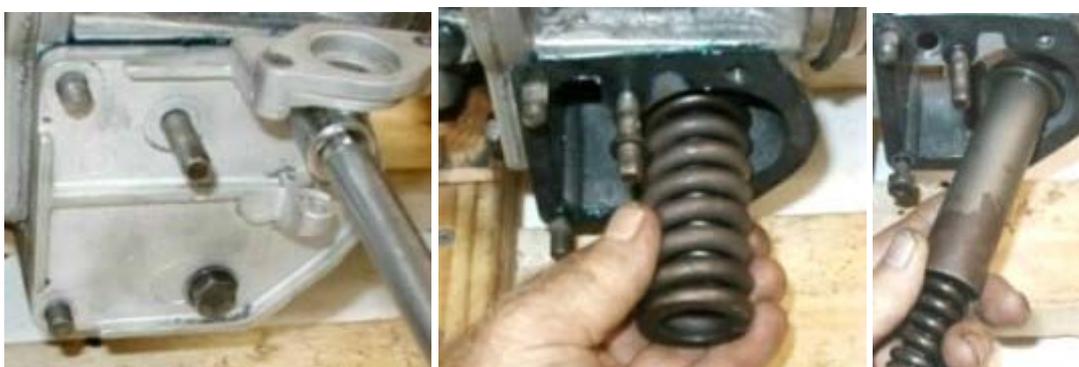
The cover that retains the humongous accumulator spring was removed next. It is secured by two bolts to the rear and two nuts on studs toward the front and must be removed properly so that it is not bent or distorted. **Caution, the operating valve must be operated and released a half dozen times using the lever or solenoid to relieve the pressure before removing the operating valve plug or the cover plate.** The nuts on the studs on the forward side of the bracket were removed first. Then the two bolts were unscrewed alternately a little at a time such that the plate comes off relatively straight (left photo below). The center photo shows the spring of the early style accumulator being removed. There was a bunch of metal parts in the sump under the accumulator, including several little ball bearings, an ominous sign. The right photo shows the removal of the spring and spring tube from a later style accumulator. (Another OD was setting nearby that is a future project. The accumulator was pulled from it from it to show a comparison. Later on you'll find we borrowed some parts from it.)

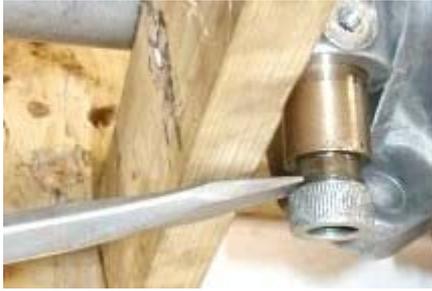
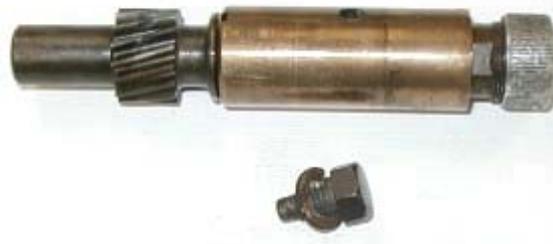
The speedometer bearing & pinion were removed next. This need be removed only if one plans to disassemble the rear casting to replace the two rear bearings. The retaining bolt was removed first, and then the nut from the end of an old speedometer cable was screwed onto the speedometer bearing and a large screwdriver was then used to pry against the lip of the speedometer nut to remove the bearing (left photo below). The parts in right photo were bagged together.

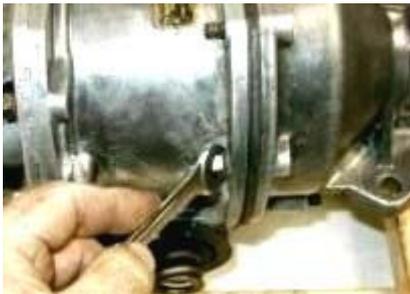
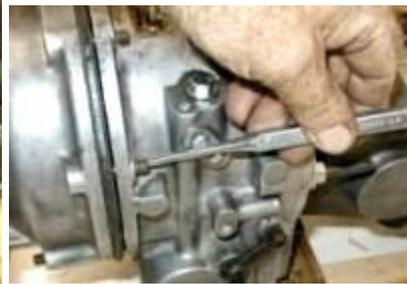
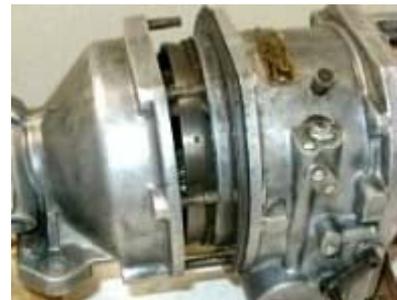
Removing the rear casting: I prefer to separate the rear casting from the main casting while the overdrive is still attached to the gearbox. Six studs hold the two castings together. The eight springs between the gearbox and the OD unit push against the annulus that helps separate the rear casting. This time, the castings didn't come apart when the nuts were removed. The ends of the studs were tapped with a punch to break the seal as shown in the middle photo below. The brake ring also came loose from the main casting so the hammer and punch were used to drive it back into the main casting. The brake ring can't be removed until the bridge pieces are removed from the thrust ring. The right photo shows the rear casting ready to slide off. Once the rear casting was off it was clear that the thrust bearing had failed --- more about that later.

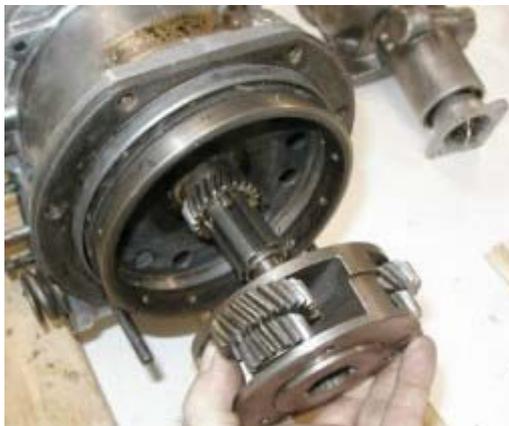
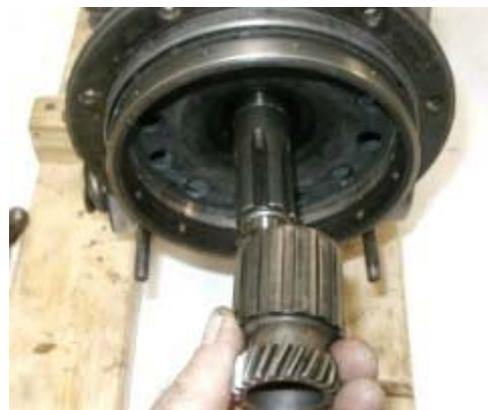
After the rear casting was removed, the planet carrier with planet gears and then the sun gear were removed as shown below. The planet carrier was cleaned and the bearings in each planet gear were tested by rotating the gears. All three gears rotated smoothly and there seemed to be no play in the bearings. It was decided that the planet bearings would not be replaced so it was not necessary to disassemble the planet carrier further.

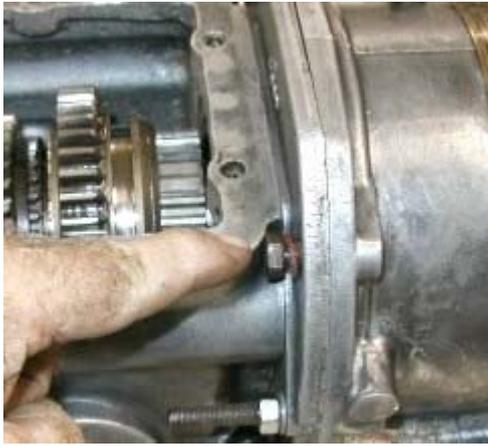
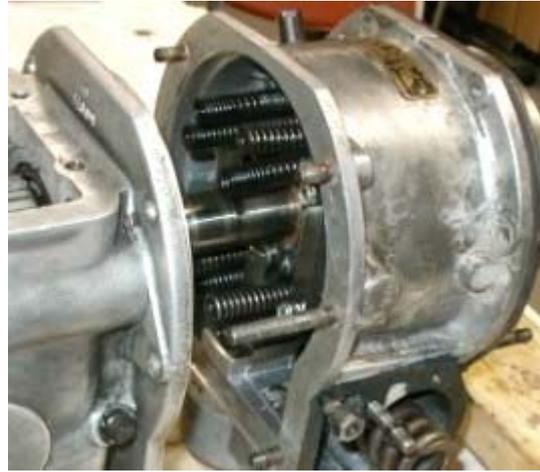
Removing Main Casting: The nuts and lock washers from the two bottom studs were removed first. Next, the nuts on the two top studs were loosened; these nuts can't be removed until the main casting is separated from the OD adaptor plate (left photo below). The nuts on the two long studs were then backed off a quarter inch or so. The casting didn't separate so I tapped it with a hammer and wood block. Once the casting separated, there was sufficient clearance to remove the nuts from the two top studs. The nuts on the two long studs were then backed off together to keep the main casting straight

eight springs were pulled out and bagged.

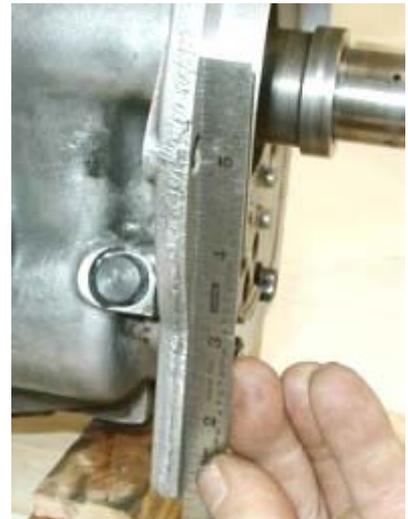
Adaptor: Before leaving the gearbox the adaptor plate surface that mates with the main casting was cleaned and a straightedge used to check to see if it was bent or bowed. If the OD had been previously forced onto the adaptor by tightening the nuts on the studs it is possible that the adaptor is distorted. This will lead to leaks. A severely bent or distorted adaptor can't be used. There have been reports of some success filling minor low spots with epoxy based fillers. The adaptor plate was OK.

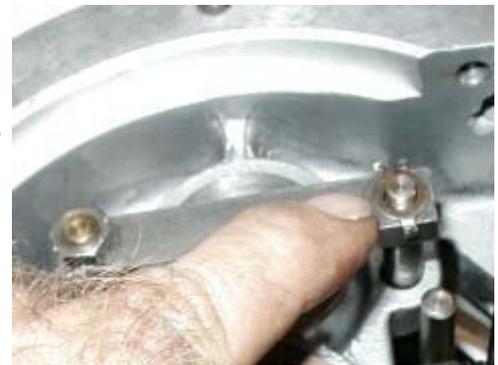
Removing Bridge Pieces: The nuts were removed from the bridge pieces next. These nuts were originally equipped with locking tabs. I prefer to not reuse these because the tabs usually break off after they have been bent once. These tabs are NA so both the tabs and nuts were discarded and replaced with 1/4-28 nyloc nuts. Once the four nuts were removed the bridge pieces were pulled off the thrust ring and the thrust ring was slid out the rear of the main casting. A bronze thrust washer and an adjustment washer were also removed from a recess behind the main shaft bushing in the main casting.

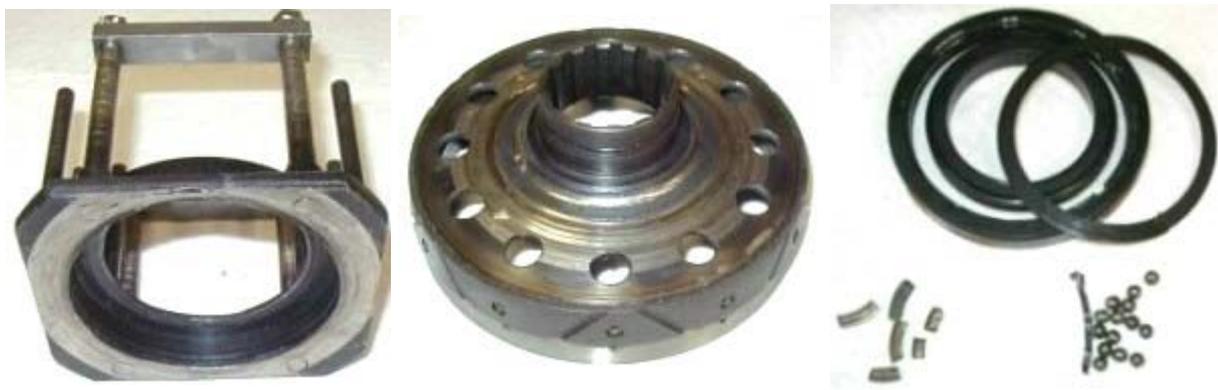
As mentioned earlier, a bit of a disaster was discovered when the OD was dismantled. The thrust bearing, that large bearing between the thrust ring and the clutch sliding member failed --- the balls fell out and the two parts separated. The eight springs then forced the thrust ring (doesn't rotate) into the rotating clutch sliding member. It must have made a hell of a racket. The left photo below shows the back side of the thrust ring where much of the metal has been worn off. The circlip retaining the bearing outer race was also damaged. The center photo shows the front side of the clutch sliding member where again, much of the metal has been worn off. The dark area indicates that it got very hot. The right photo shows the remains of the bearing. The pieces in the lower left hand corner of the right photo are the remains of the thrust washer between the sun gear and the planet carrier. It was decided to reuse the clutch sliding member since the clutch surfaces, the splines and the collar that mates with the bearing inner race were not damaged. The thrust ring was so heavily worn that the lip retaining the bearing outer race circlip was missing in some places. The thrust ring and circlips in addition to the destroyed thrust washer and bearing were replaced. Because some of these metal pieces were floating around the OD it was decided to also replace the two annulus bearings in the rear case.

Because the OD discussed here was damaged due to the bearing failure, the following parts in addition to the previous two lists were required:

- Thrust Ring
- Thrust bearing large circlip
- Thrust bearing small circlip
- Thrust washer between sun gear and planet carrier
- Operating valve plug (the one we welded a nut to so that it could be removed)
- Operating piston (broken ring)

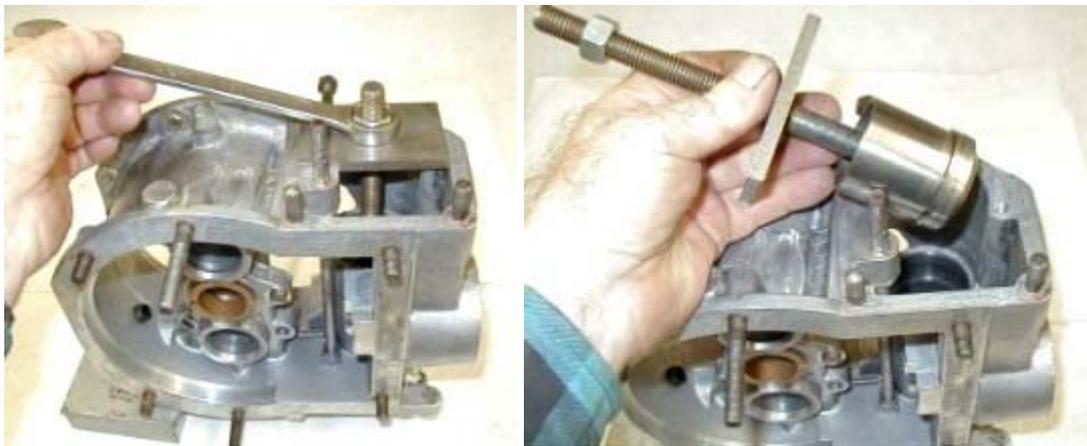
Removing Accumulator Piston: This OD was an early model with the Accumulator cylinder machined into the main casting. The center of the piston has a hole threaded 3/8-24 (this was previously reported as 5/16 -24 - thanks to Dan Shockey for the spotting the error). A puller was made by turning down the end of a 1/2 inch threaded rod (had a stack of these left over from a church project ten years ago) and then threading 3/8-24. A length of 3/8-24 threaded rod would have worked just as well. Not much force was required to remove the piston. The photos below show the puller in action. After the piston was removed, the rings and the cylinder walls were examined for defects. We were lucky; the metal pieces from the bearing failure didn't seem to have made it to the accumulator.

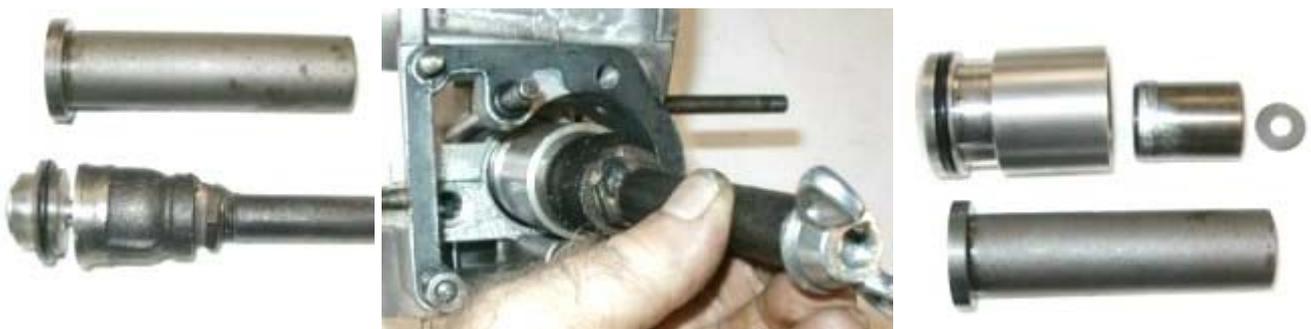
The photos below show removing the later style accumulator. An extraction tool that expands an O ring into the end of the accumulator piston housing where the spring tube fits was fabricated. The tool and spring tube are shown in the left photo below. The O ring and tool outside diameter is 1.5 inches. The inner diameter of the end piece is 1.25 inches, the ID of the O ring. A 3/8 inch bolt extends the length of the tool. Tightening the wing nut pulls the end cap into the main piece and squeezes the O ring out to grasp the accumulator piston housing. Both the tool body and wing nut had to be grasped with pliers to tighten the nut sufficiently to grasp the housing. In the process, the plastic end piece cracked. (Next time I'll make the end piece of steel or aluminum). Once the housing was removed, the piston was easily pressed out the top of the housing. Everything was in order and no problems found. One interesting note, the washer in the right photo is a low quality hardware store type, obviously added well after manufacture. Putting a washer behind the spring is the accepted way to increase the accumulator pressure.

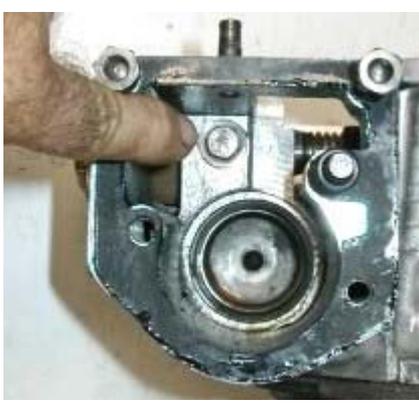
Removing Non-Return Valve: The pump non-return valve is located beside the accumulator cylinder as shown in the left photo below. After the plug was removed the spring, plunger washer, and ball were removed, cleaned, inspected and stored (right photo).

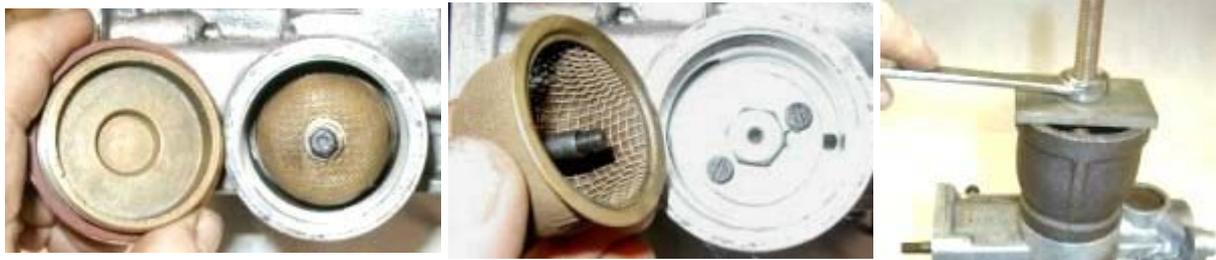
Removing Pump: The drain plug and screen filter must be removed to expose the pump.. The photos below were taken after the gearbox had been cleaned up. Much of the oil evaporated from the heat generated when the bearing failed. The outside of the screen was covered by black goo mixed with metal parts. (The later models use a larger plug and the screen is retained by the plug rather than the screw as shown in photos below.)

The pump is pressed into the case and requires quite a bit of force to remove. **Caution - the non-return valve must be removed before the pump body is extracted.** The two screws and plug shown in the middle photo below were removed first. A threaded rod screwed into plug hole was then used to pull the pump body. The threads are 7/16-20. The end of another one of those 1/2 threaded rods was turned down and threaded to make a puller --- right photo below. A length of 7/16-20 threaded rod would have worked just as well. A pipe fitting was used to provide a space to draw the pump into. The pump body came right out as the nut was tightened.

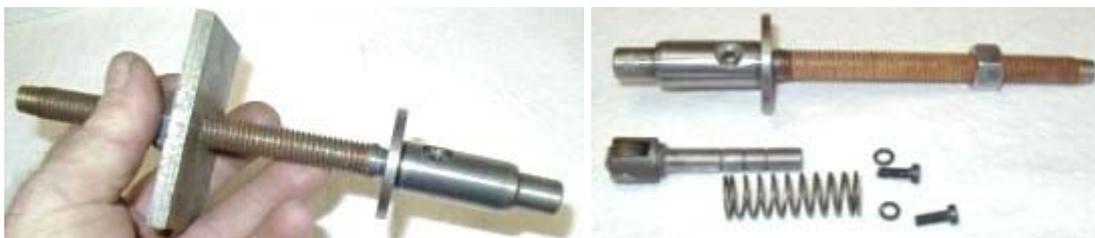
The extracted pump body is shown on the left and with the piston and spring on the right. The hole in the side of the pump body is the seat for the non-return valve ball. The pump components were examined for signs of wear and the valve seat for nicks. The free length of the spring was measured and found to exceed the 2 inch minimum spec.

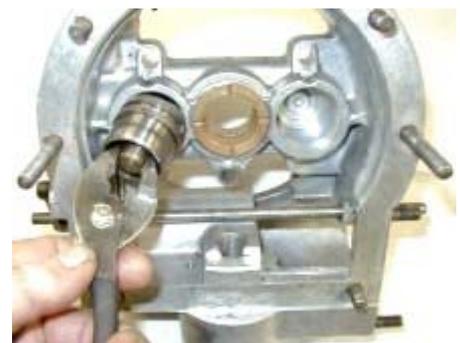
Removing Operating Pistons: The operating pistons were removed by grasping the ends with pliers and rotating the pistons back and forth while pulling out. Upon inspection one of the piston rings was found to be broken. Quite possibly it was broken when initially installed. These rings are no longer available so the new style piston with O ring seal had to be purchased.

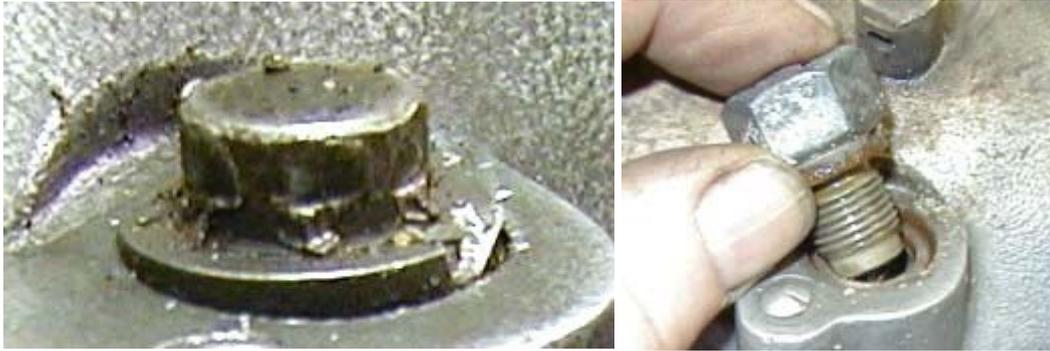
Removing Operating Valve: The last thing removed from the main casting was the operating valve. The valve plug is on the upper right-hand side of the casting. Unfortunately, the corners on the hex

room to get another type of wrench on it. A 1/2 inch nut was driven over the top of the plug and welded. The nut and plug were then removed together. The plug with the large nut attached is shown at the right.

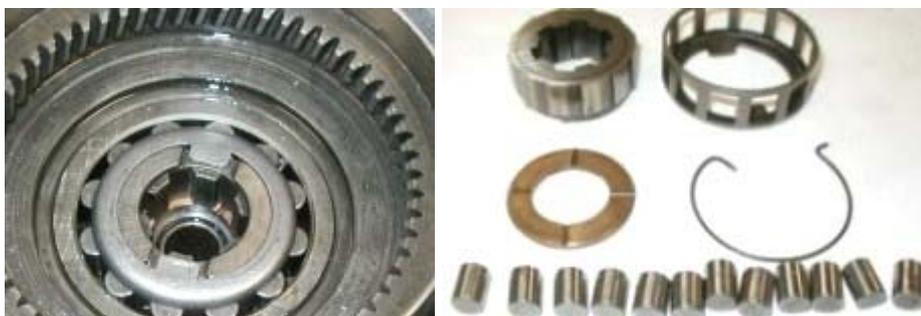
Removing Unidirectional Clutch: The unidirectional clutch sets in a recess in the large end of the annulus in the rear casting (left photo). It is removed by rotating the center part counterclockwise and lifting up. The rollers came out of the cage so then we had a bunch of pieces as shown in photo on right below. The bronze thrust washer is located behind the clutch.

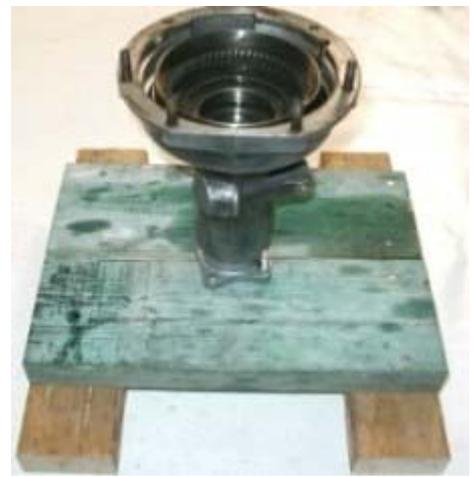
OD Stand: A stable base to hold the OD on end during reassembly is very useful. The old piece of 2X12 used previously had disappeared so the new stand shown on the right was made from scrap lumber. A 1 1/2 inch hole in the center provides clearance for the end of the annulus shaft and nut. Two 3/8 inch holes provide for bolts to hold the rear flange.

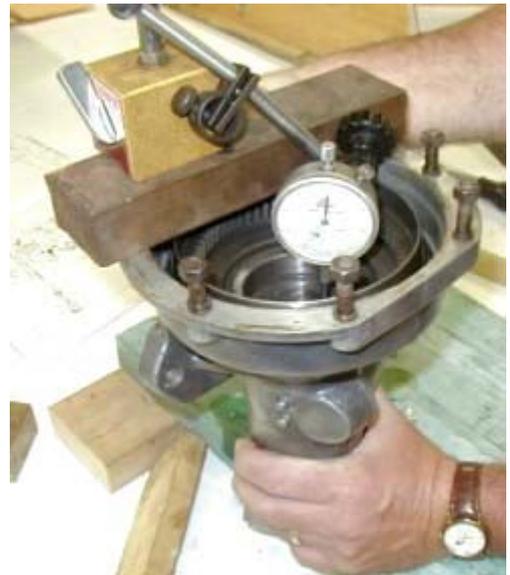
Annulus End Float: The annulus end float was measured before the rear casting was disassembled. The end float is adjusted by changing the adjusting washer between the rear bearing and a shoulder on the annulus shaft. If the end float is within spec before disassembly, then it should be within spec even if new bearings are installed because the bearings are made to a very close tolerance.

The rear casting was secured to the stand and a dial indicator was positioned as shown with the point against the annulus. The casting was then pushed down for the first reading. The second reading is taken after the casting has been pulled up by placing one hand on each side the top of the casting and pulling up while pushing down on thumbs pressing against the outside of the annulus. The required end float is .005 to .010 inches. If the end float is out of spec, refer to the discussion near the beginning of Part III. This end float was right on .005 inches.

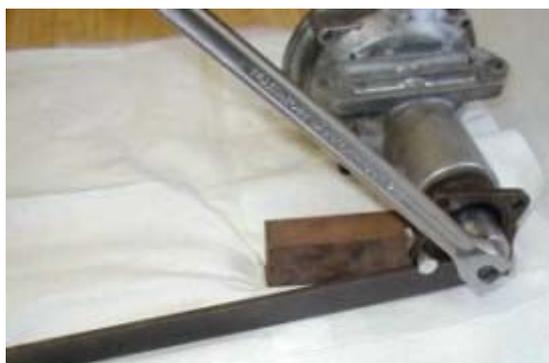
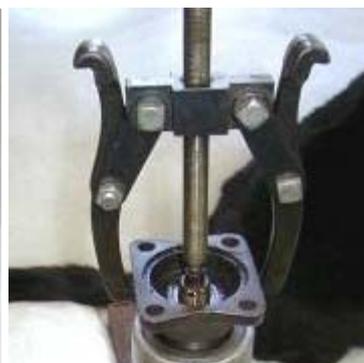
Rear Flange Removal: A "flange removal tool" made from a two foot length of 1/4 inch by 1 1/4 inch steel bar (a 1 inch bar will probably work as well) is used to hold the flange when removing the nut. A 3/8 inch hole is drilled close to the edge near the end for attachment to the rear flange. A second bolt is installed in the flange to rest against the edge of the tool to keep the flange from turning as shown in left photo below. This bar is also a "flange installation" tool. It can also be attached to the flywheel using one of the clutch pressure plate bolts to become a "flywheel removal or installation tool". The cotter pin was removed from the flange nut and then a breaker bar was used with the tool to loosen the nut.

A puller was used to remove the flange as shown in the right photo. The black object is one of the cats that live in the workshop. This is the dumb one; she is so dumb her fur should be blonde.

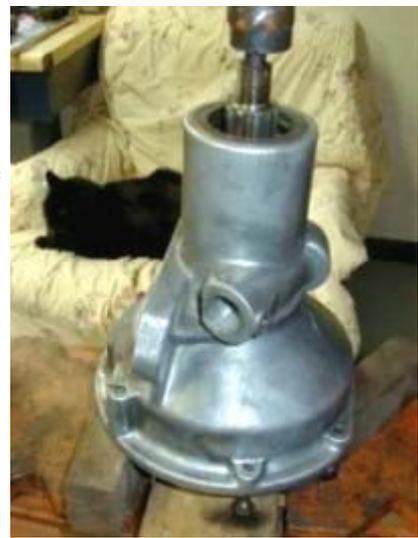
Removing the Annulus: The annulus was pressed out of the rear casting using the hydraulic press as shown on the right. The sides of the casting were blocked up off the press cross members. A scrap piece of 2X4 was placed under the casting to stop the annulus from slamming into the steel press cross member if it came loose with some velocity. This was a well behaved annulus that came out gently with minimum force applied. The annulus is shown in the photo below. The middle bearing must still be removed from the annulus shaft.

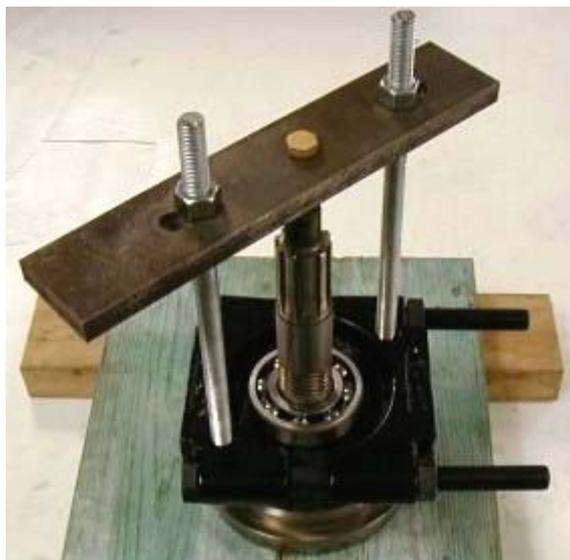
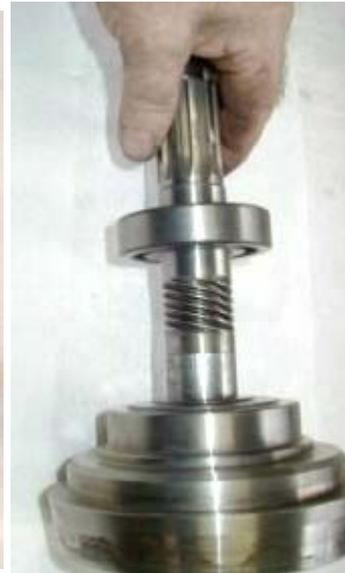
Middle Bearing removal: This bearing is also known as the annulus head bearing. A large bearing separator (available from Harbor Freight, ~\$20) was used to first push the bearing away from the shoulder on the annulus by tightening the two black bolts in the left photo below. Next, the bearing was pulled along the shaft by tightening the nuts on the threaded rods. The right photo shows the bearing nearly off the shaft. The press fit is only on the shiny section very near the shoulder.

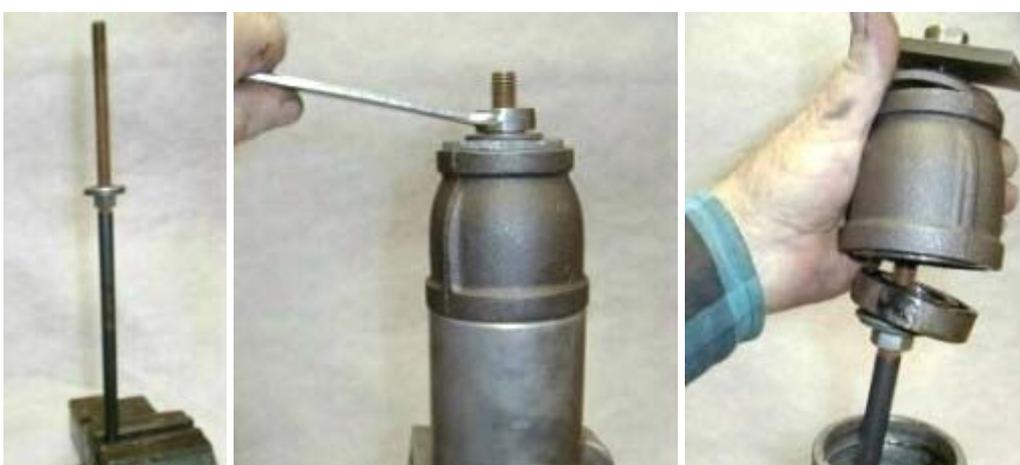
Rear Bearing & Seal Removal: A length of threaded rod, some washers and spacers were used to pull the rear bearing (aka annulus tail bearing) and seal from the rear casting. This is the same stuff used to press rear bearings and seals out of the gearbox extension of non OD gearboxes. The rod was secured in the vise as shown on the left. The rear casing and then a spacer and washer were slid over the rod and a nut threaded on and tightened. The lower washer on the rod pressed against the under side of the rear bearing. As the nut was tightened, the spacer pushed the casting down off the bearing. The freed bearing is shown on the right. The rear seal has been pushed up into the spacer; the bottom edge of the seal is visible.

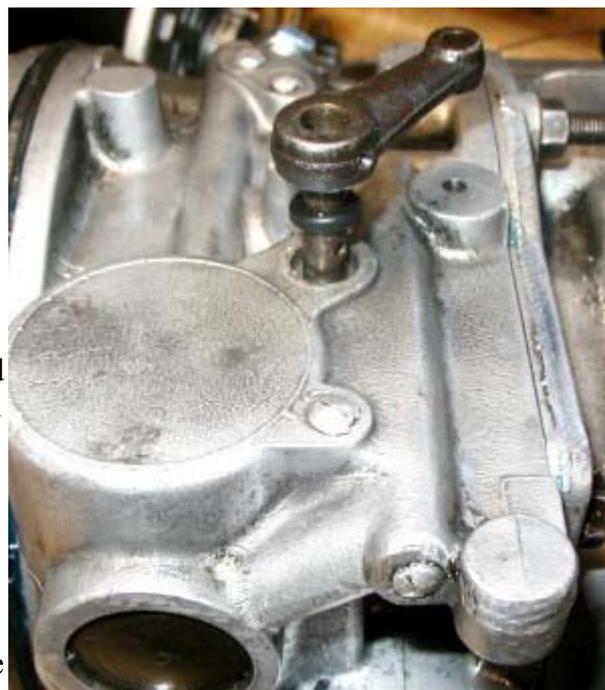
Setting Lever O Ring: There is a small O Ring behind the setting lever on the right hand side of the main casting. The lever must be removed to get at the O Ring. The lever on the later units is secured by what the Brits call a spring dowel (roll, tension or expansion pin in the US) that can be easily driven out with a suitable size punch. The earlier units as that shown on the right have a solid dowel pin. I drilled it out using a sequence of 5/64 - 3/32 - 7/64 drills. The holes are 1/8 inch. The photo shows the lever pulled to the end of the shaft and the O ring pulled out of the recess. I used a sharp scribe to pry the O ring out of the recess. The lever was pulled off, a new O ring slid into position and the lever reinstalled and secured with a 1/8 inch tension pin. The tension pin on the later units seems to be a little smaller, possibly 3/32 inch. I'll update this when I take one of those apart next time. This section was added on 10-9-01 after Mike Kitchener mentioned that these O rings were missing from the parts list. I then realized that hadn't replaced the O ring under the lever on the unit described here. The battery was dead on the hand drill when I first took it apart, so I deferred it and then forgot. I replaced it today on the fully assembled unit --- no problem.

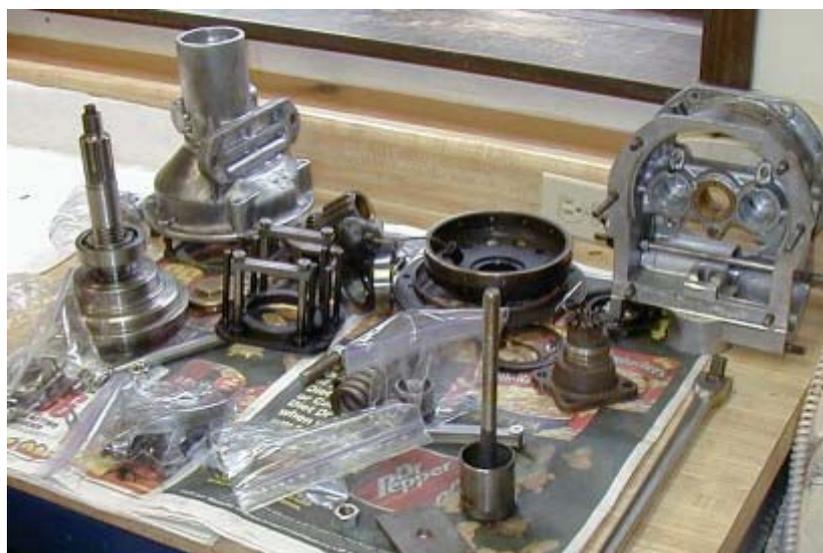
All the parts: The photo below shows all the parts extracted from the OD unit after they had been cleaned up and packed with associated components.

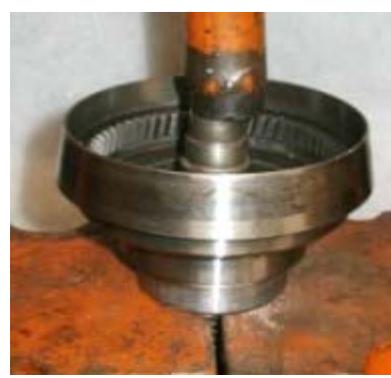
Installing Annulus Head Bearing: The annulus head bearing (or OD middle bearing) was pressed onto the annulus shaft until it was snug against the shoulder. A hydraulic press as shown in the photo on right was used.

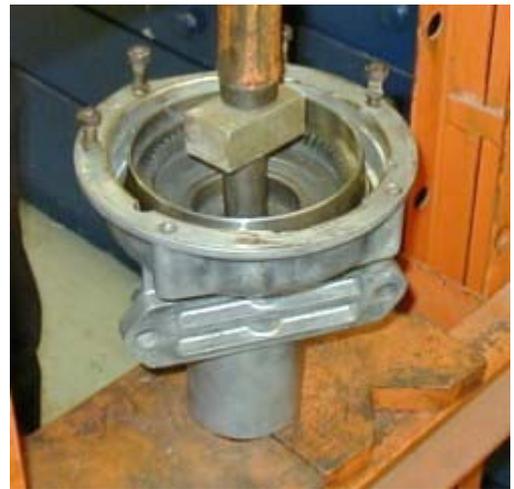
Installing Annulus in rear Casting: The press was used to push the annulus into the rear casting. First, the rear adjustment washer was slid on the tail end of the annulus and then the annulus was fed into the rear casting. (There was no confusion as to which washer was the annulus adjustment washer and which was the washer under the nut, the adjustment washer has smooth sides and the one under the nut has gouges from the nut being tightened.) The tail bearing was then slid over the tail end of the annulus and into the end of the rear casting (the casting diameter is larger near the end to accommodate the rear seal, the bearing slides easily into the first half inch or so). The tail bearing was put in at this point to keep the shaft aligned during the pressing operation. Everything was then put in the press as shown on the right. Care was taken to assure that the head bearing was starting into the recess properly before applying heavy forces. Also, no more than the minimum force required to seat the bearing was applied to minimize any stress on the bearing.
