A Type Overdrive, Part I - Theory

Overview: The A type overdrive (OD) unit described here was manufactured by Laycock-de-Normanville and was a factory option on the TR2, TR3, TR4, TR5/250 and TR6 Triumphs through 1972. The function of the OD is to change the overall reduction ratio between the engine and rear wheels. It operates in two modes, the direct drive mode where there is no change in reduction ratio and the OD engaged mode where OD provides a 22% rpm increase in the output over the input rpm (i.e. overdriven). This means that for a given engine rpm, the road speed is 22% greater when the OD is engaged. Another way of saying this is that when the OD is engaged, the engine rpm is reduced by 18% for a given road speed. The OD is operator controlled via an electrical switch on the dash or steering column, depending on the model. The OD could be engaged only in 4th gear in the early TR2 application. The operation was changed after TR2 s/n TS5980 so that it could be engaged in the top three gears.

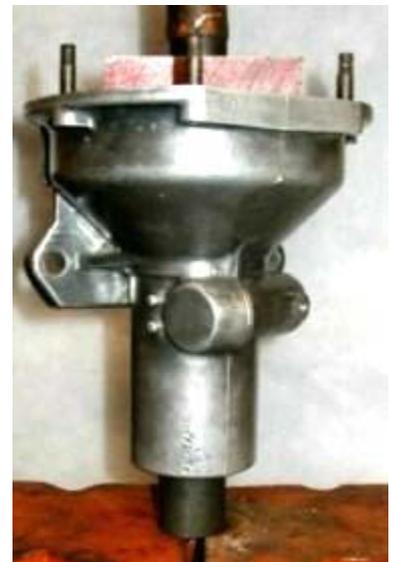
Installing Annulus tail Bearing: A large thrust washer (originally from a gearbox) was placed over the end of shaft and against the side of the bearing and a pipe coupling spacer was slid over the shaft as shown in the photo on the right. This is the same as the previous setup except the annulus is being pressed into the tail bearing instead of the rear casting. The press force was limited to that necessary to get the bearing seated.

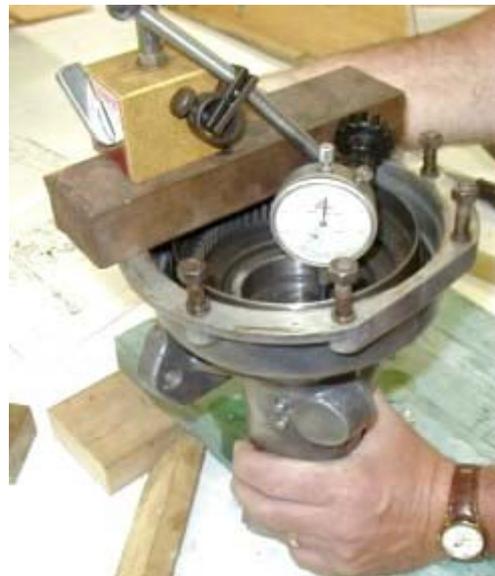
Measuring Annulus End Float: The annulus end float was measured again using the same procedure described in Part II. The dial indicator tip was positioned against the annulus. The casting was then pushed down and a first reading taken. A second reading was taken after the casting had been pulled up by placing our hands on each side of the casting and pushing down on the annulus with our thumbs. The difference between the two readings is the end float. The end float was within the .005 to .010 inch specification before the unit was disassembled so it was expected to be within specifications after reassembly, even with new bearings. In this case it was. If it were not, one of the bearings might not be seated. The first thing I'd try is to use a punch to drive the tail bearing outer race a little further into the rear casting. The next most likely problem is that the head bearing inner race isn't seated against the annulus shoulder. One might have to go back to the first step above to make sure the head bearing is seated properly. Another possibility is that the old bearings were worn and sloppy. If the bearings are seated properly and the end float is still out of specs, read on.

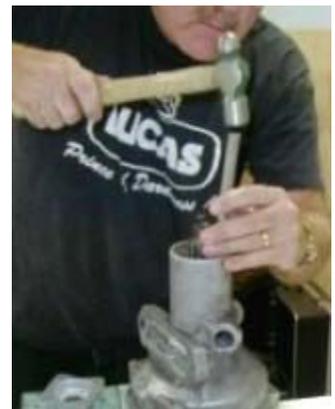
Installing Rear Seal: After the adjustment washer was installed and the end float found in spec, the shaft was rotated to make sure it turned smoothly and freely. The rear flange was then removed and the rear seal installed. An ounce or so of oil was poured over the rear bearing to make sure it was lubricated at startup. A small amount of grease was spread around the outside of the seal and also on the inner lip. The seal was inserted lip forward and tapped into place using a punch. The front of the seal rests against a shoulder in the casting as shown in the previous sectional drawing. That is the current owner of the OD (undoubtedly someday to be unjustly know as the DPO) busy at work. Don't you love his shirt?

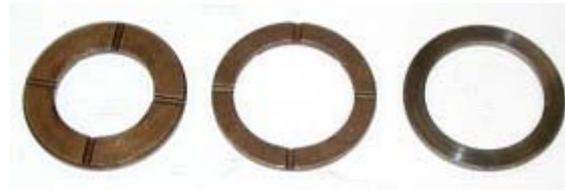
Washers: There are a total of 6 washers that fit over the mainshaft and annulus shaft. Each washer was carefully bagged with the associated parts so that they wouldn't get mixed up. However, along the way they got all mixed up. No reason to panic, they are all different and easy to tell apart. The three washers shown below all go on the mainshaft. The left washer is the bronze thrust washer that goes between the unidirectional clutch and the annulus. The center washer is the bronze thrust washer that goes between the sun gear and the main casting. The right steel washer is the adjustment washer that also goes between the sun gear and the main casting. Note that the left thrust washer is much wider with a smaller ID. The right two washers have the same ID & OD. There is one more thrust washer that fits and is held inside the planet gear carrier. It is easy to identify because the edges on one side are beveled. The two steel washers that fit on the annulus can be differentiated from the right adjustment washer in the photo because they have a slightly larger ID; the right adjustment washer in the photo is too small to slide on the annulus shaft. (Sorry that I forgot to take a photo of all six washers together; when I thought of it the other three were already in place and I was not about to take them out.)

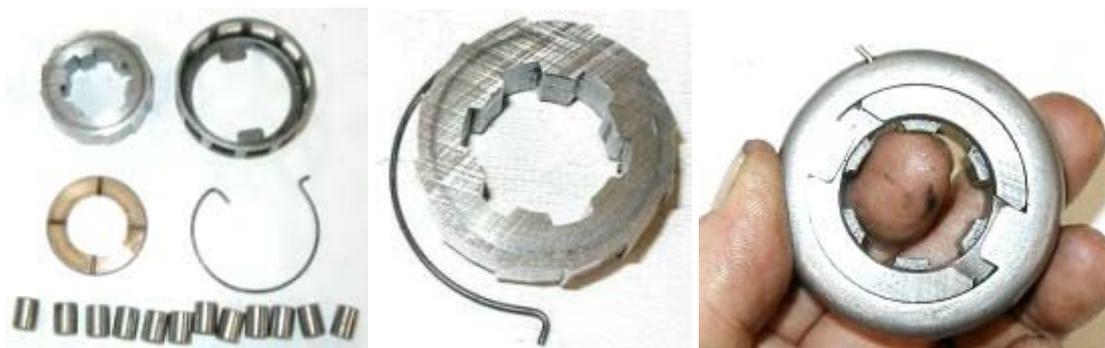
Assembling the Unidirectional Clutch: The parts of the unidirectional clutch in the left photo below are inner member (upper left), cage, spring, thrust washer and rollers. The spring was connected to the inner member first as shown in the middle photo. There are two ways to connect the spring, only one is correct. Next, the other end of the spring was slipped into the hole in the cage, followed by the inner member. The inner member was then rotated against the spring and locked into place by the cage tabs shown in the right photo. The end of the spring can be seen sticking out of the cage in the right photo.

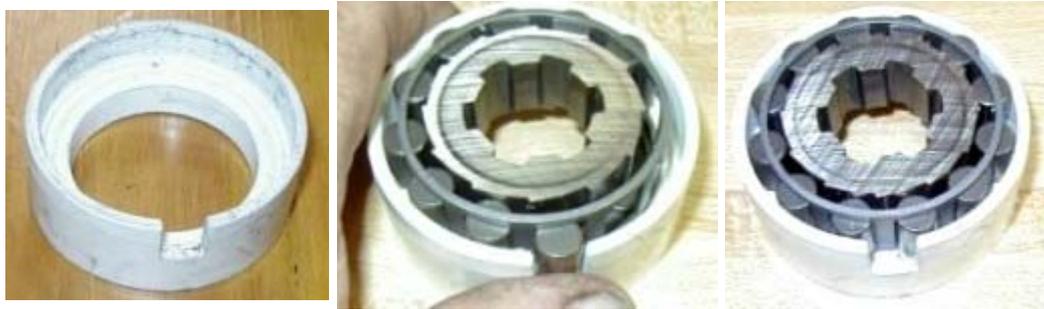
The 12 rollers must be inserted into the cage next. One way to do this is to wrap a heavy rubber band around the cage and then lift it and feed the rollers into position one at a time. The manuals show photos of a Churchill tool to help assemble the clutch. A similar tool was fabricated using a plastic pipe coupling and bushing as shown in left photo below. The inside was turned to a diameter just less than the inner diameter of the recess for the clutch in the annulus and to a depth slightly less than the clutch thickness. The slot in the side is just wide enough for a roller to pass. The cage with inner member is placed in the tool as shown in the middle photo and the rollers fed into the cage. The inner member is rotated clockwise after each roller is inserted. If an attempt is made to turn the inner member counterclockwise, the clutch will lock. (If it doesn't lock, then the ramps are probably not positioned as shown in photo and it must be taken apart and reassembled, making sure the spring is installed in the correct direction.) The assembled clutch is shown in the right photo.

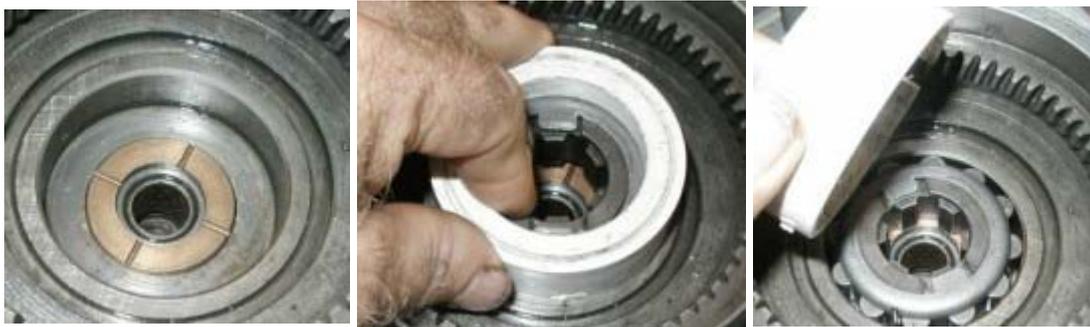
Installing the unidirectional Clutch: The rear casting was still mounted to the OD stand. The thrust washer was positioned (left photo), the tool with clutch inside was placed over the recess and the clutch pushed into the recess (center photo), and the tool lifted away (right photo). If one used rubber bands to assemble the clutch, then the procedure is the same and the rubber band would slip off as the clutch was pushed into the recess.

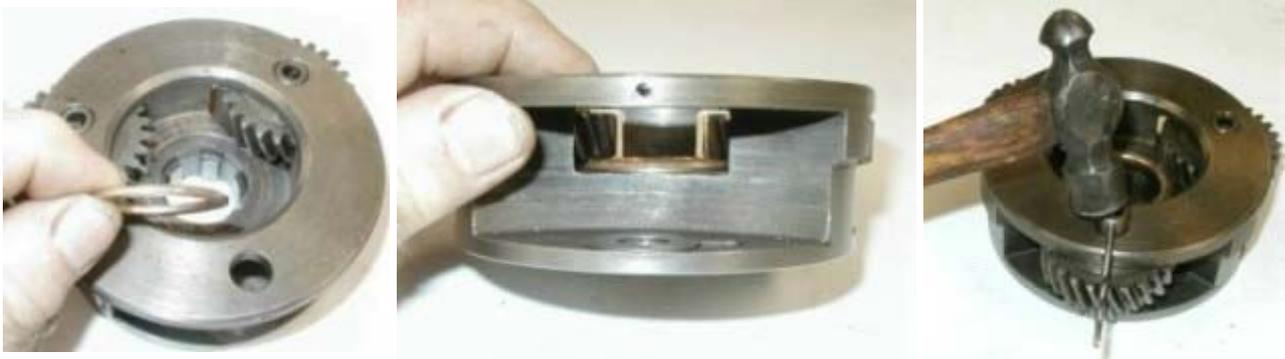
The thrust washer was positioned in the recess in the center of the carrier. The top of the washer is beveled to provide clearance for the planter gear teeth. (If the top of washer isn't beveled, one can try turning it over.) The planet gear thrust washer was then positioned with the tab in the hole, the gear slid into position and the shaft tapped home using a small hammer. The photo on the right shows a drill bit in the hole in the shaft to help keep it visually aligned with the hole in the carrier. A 3/32 steel retaining pin didn't seem tight enough so a 3/4 inch long 3/32 expansion pin was ground down to a length of ~ .6 inches and used instead. The expansion pin is tempered and will likely ruin a drill bit if one tries to drill it out. However, if the shaft is pressed out, the pin will shear off and the pieces can then be tapped out with a small punch. (I tried it to make sure it works.)

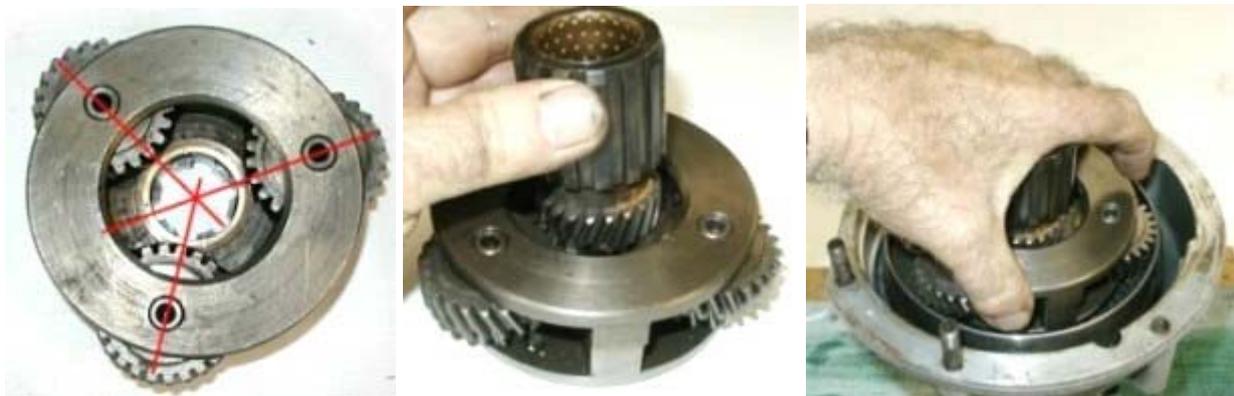
Measuring Sun Gear End Float: A thrust washer and adjustment washer fit between the sun gear and the bushing in the rear of the main casting (left photo below). When everything is put together, the sun gear must have an end float of between .014 and .020 inches. The books tell you to put an extra washer (thickness over .025 inches) on the mainshaft, pound the brake ring in the main casting and slide the main casting into position. Because of the extra washer, there will be a gap between the brake ring and the rear casting. Measure that gap with feeler gauges and subtract the measured value from the size of the extra washer to determine the end float. For example if the gap is .025 inch and the washer is .040, the end float is .015 inch. I was unable to get a repeatable measurement using this method --- the brake ring was on crooked, slid down from the main casting, or main casting tilted, etc.

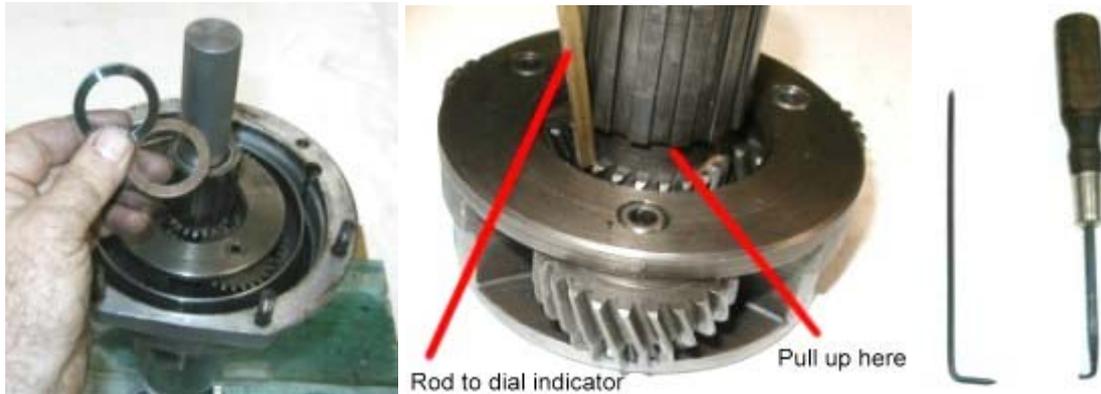
The left photo below shows the actual setup. A fairly large steel bar was used to secure the indicator magnetic base and provide stability. The right photo shows a young LBC mechanic wanabe at work.

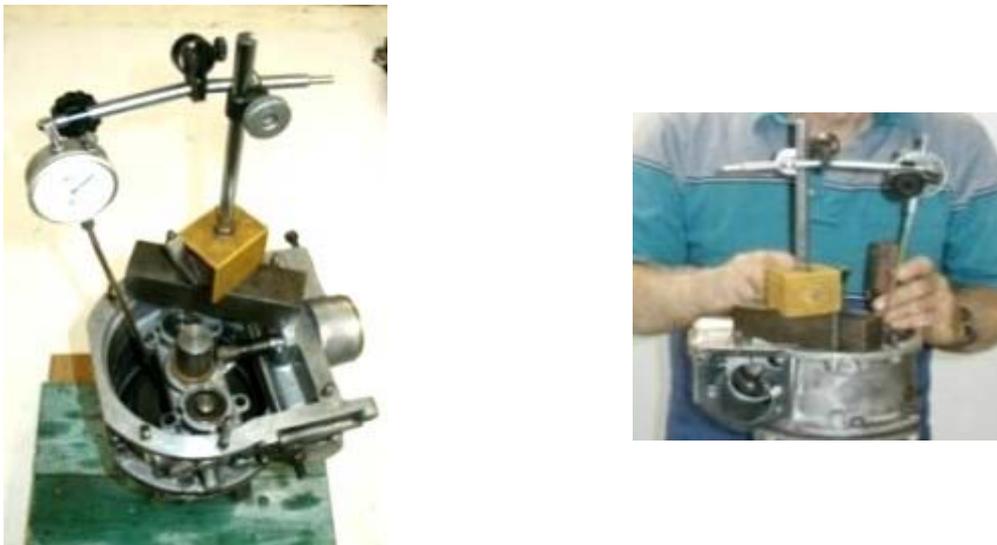
No End Float! When the end float was measured with the dial indicator there was none. That was the same result I got using the extra washer method --- but the problems mentioned earlier caused variations of about .010 inch so I didn't know for sure. A problem was suspected because the thrust washer had a groove worn in it. Also, remember that the thrust washer between the sun gear and planet carrier had been destroyed.

After filing off that ridge, everything was put together to measure the end float again ---- it was about .012 inches this time. Still a little short. There was no hurry this time (I was waiting for a motor to arrive for a test stand --- see next part) so the next size smaller adjustment washer was ordered. A replacement for the damaged thrust washer had been purchased when parts were ordered parts earlier. Unfortunately, I couldn't find the damn thing. Maybe the workshop cats ate it -- or the mice carried it off. The rough

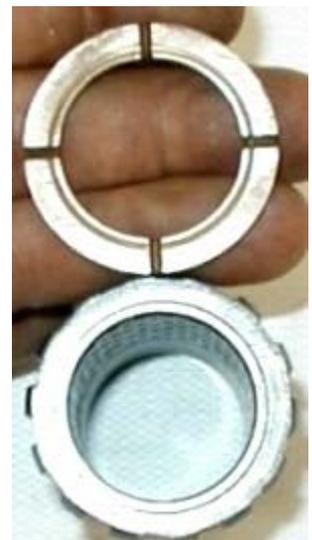
Closer examination of the trust washer and sun gear revealed that the bushing pressed into the sun gear was not flush with the top of the gear --- it stuck up at least .010 inches. This bushing has a steel outside and brass or bronze inside. The steel outside part had cut a groove in the thrust washer as shown in photo on right. An attempt was made to press the bushing in further --- wouldn't budge. The protruding part was then filed off smooth. (Photo is after it was filed.) The thrust washer groove was positioned away from the sun gear in the earlier measurements, which explains the lack of end float.

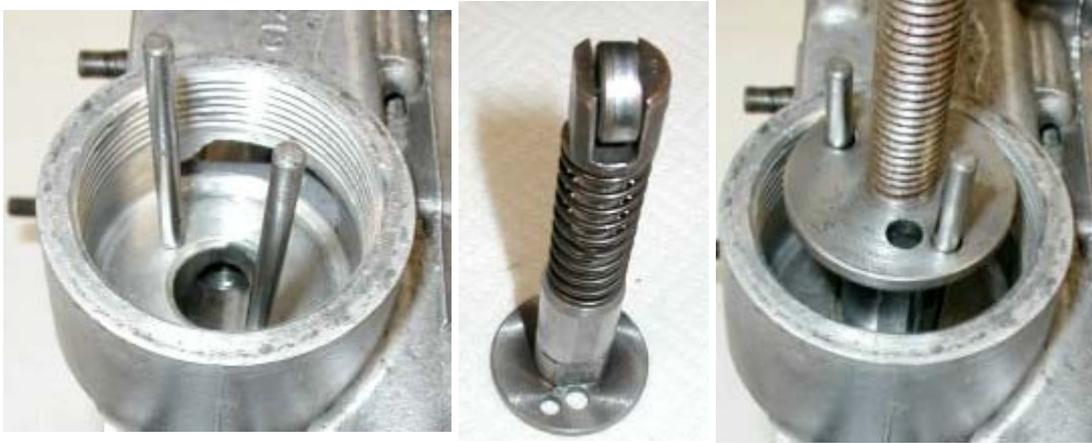
Installing the pump: The next step was to press the pump into the main case. The ends of two 2 inch long 3/16 steel rods were threaded 12-32. These rods were then screwed into the pump retaining screw holes to guide the pump housing into the correct position (left photo below). The rod used to extract the pump was then screwed back into the pump. Both the inside and outside of the pump body were lubricated, the spring slipped on the piston and the piston with spring slipped into the pump body. The end of the piston is asymmetric as seen in the middle photo. The thin side is positioned next to and slides beside the steel pin in the main casting. The pump with piston was slid into position over the pins. Before pressing the body in, the thin side of the top was verified to be next to that pin and the hole in the pump body was on the correct side to match up with the hole for the non-return valve. After everything was positioned correctly, the pump home was driven home using a hammer on the end of the threaded rod. The large threaded rod and two smaller rods were then removed. A little oil was poured into the pump housing and then the plug was installed followed by the two small screws. The screen filter was installed next, and then the drain plug with a new washer/gasket. This OD didn't have the magnets under the filter that are used on the later ODs.

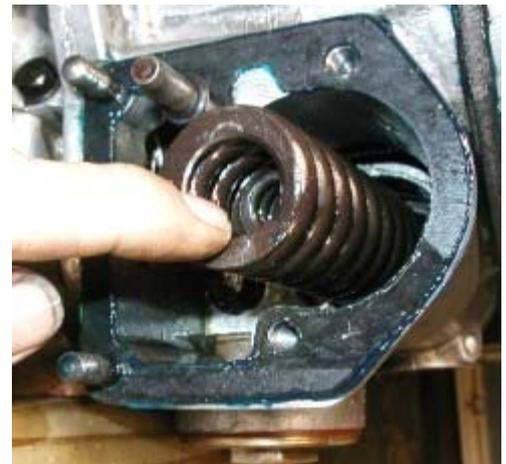
Installing Accumulator Spring(s) & Cover: The two accumulator springs were inserted into the accumulator piston. (If the accumulator was the later type, it would have been one spring and the spring tube.) Both sides of the cover plate gasket were coated with sealer, the gasket was positioned between the cover plate and the main casting and then the sealing O ring was placed on the operating valve shaft. The cover plate was then drawn down using the two long bolts, alternating tightening each a few turns to keep the cover square as it compressed the spring. When the cover plate started to slide over the two studs, it was tapped it in the area of the studs to make sure it wasn't hanging up on the studs. After the two bolts were tight, the dust shield and lock washers were slipped on the studs followed by the nuts. Mounting the actuating lever and solenoid was deferred until after the unit was tested.

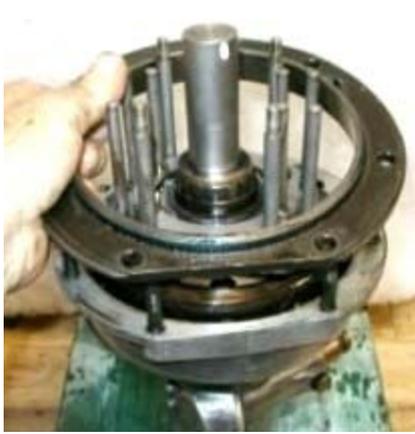
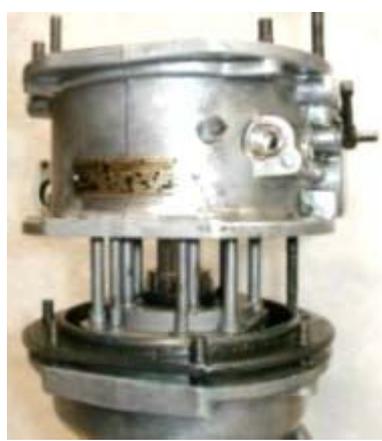
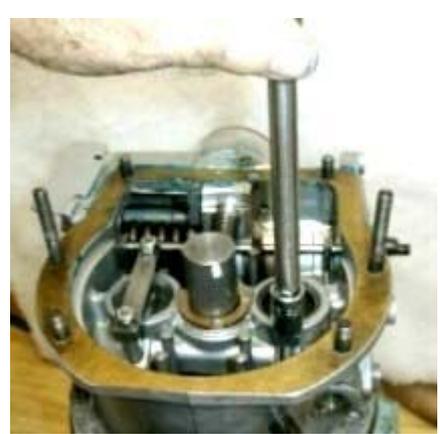
Mating the two castings: The sliding clutch was positioned over the sun gear shaft on the rear casting that was still mounted to the OD stand. A small amount of sealer was spread on the surface of the brake ring that mates with the rear casting and the ring was driven home with a hammer and punch (left photo below). A small amount of sealer was then spread on the surface of the brake ring that mates with the main casting. The dummy mainshaft was still in place and the thrust washer and adjustment washer in front of the sun gear were still in position. The main casting was then positioned on the rear casting/brake ring with the four threaded end thrust ring rods going though the holes in the main casting. The main casting was tapped into position (wood block & hammer) and drawn tight with six nuts and lock washers on the studs. The center photo below shows the two castings in position. Some sealer may ooze out after everything is tightened. The Hylomar sealer stays sticky for weeks and makes a big mess. The excess was removed using a paper towel dampened with mineral spirits. The last thing was to position the two bridge pieces on the thrust ring rods and secured them with nyloc nuts (right photo).

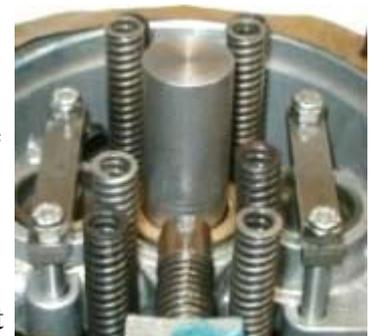
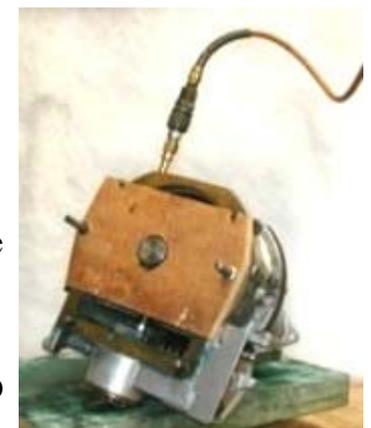
Preliminary Test: Prior to installing the OD on the gearbox a test was run using compressed air to make sure the valves and pistons were working. An adaptor with 1/4 pipe threads on one end and a plug for the operating valve on the other (top photo) was made. This adaptor was used first for injecting air into the hydraulic system and later for a gauge to measure the hydraulic pressure. The adaptor was made such that the operating valve spring, plunger & ball were positioned properly and the valve operated with the adaptor in place. A damaged operating valve plug and a 1/8 inch pipe tap were available to do the job. The first plan was to drill and tap the plug for a 1/8 inch pipe nipple. Unfortunately, the 1/8 inch pipe thread was nearly 0.4 inches in diameter and the plug head was a 7/16 inch hex --- insufficient clearance. Instead, the plug was drilled and tapped 1/4-28. Next, an adapter from 1/4-28 to 1/8 inch pipe threads was made from a 1/2 inch bolt. The length of the 1/4 inch part threaded into the operating valve plug was such that depth of the recess in the plug for the valve spring was unchanged. A 3/32 hole was drilled through the adaptor for fluid flow. A 1/8 inch nipple and a 1/4 inch to 1/8 inch reducer completed the setup. The nipple was of sufficient length so when later used with the gauge, the gauge was above the gearbox top cover so that it could be installed and removed easily.

Next, the eight springs were installed over the rods on the the thrust ring as shown in the middle photo. The long springs go on the outside and the short ones on the inside. A couple holes were drilled in a plywood scrap and it was bolted it to the front of the OD to simulated the adaptor plate, compressing the 8 springs in the process (bottom photo). The air line was connected and the lever below the operating valve plug was pushed down. There was an audible clunk as the clutch shifted into OD and a slow air escaping sound when it returned to direct drive.

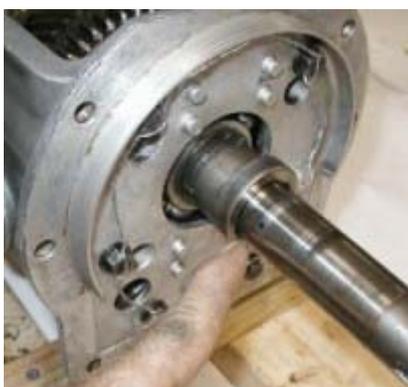
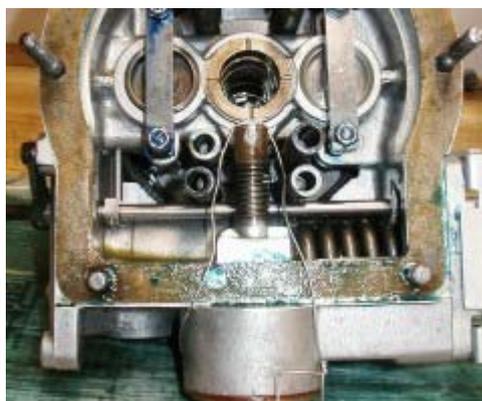
Getting Ready to Mate: The gearbox was engaged in 4th gear, the mainshaft rotated till the pump cam was positioned with minimum height at the bottom and the mainshaft was positioned with a spline pointed up; this position was then marked on the rearmost gear in the gearbox (Whiteout on the tooth at center top). Next, gasket sealer was applied to both sides of an OD to adaptor gasket and the gasket placed on the OD. The pump piston was then pushed down and a piece of 20 gauge wire used to hold it depressed. The wire was run in front of the little wheel at the top of the pump and then around the drain plug. This allowed the pump to slide past the low point on the cam when the OD was mated to the gearbox. The eight springs were then slipped over the thrust ring pins. The four shorter springs go on the pins closest to the center. Our springs seemed to have a continuum of lengths from about 3.8 to 4 inches. According to The Service Instruction Manual, the springs should have free lengths of 4 1/4 (short) and 4 1/2 inches (long). The springs seemed robust and we assumed they were a bit compressed due to old age. I selected the longest and put them on the outside. (This came back to bite later).

The dummy mainshaft was then rotated so that the spline was at the top and this position marked by putting a dab of Whiteout on the rear flange opposite the parting line at the top of the rear casting. The dummy main shaft was removed and a small amount of oil was poured into the main shaft hole.

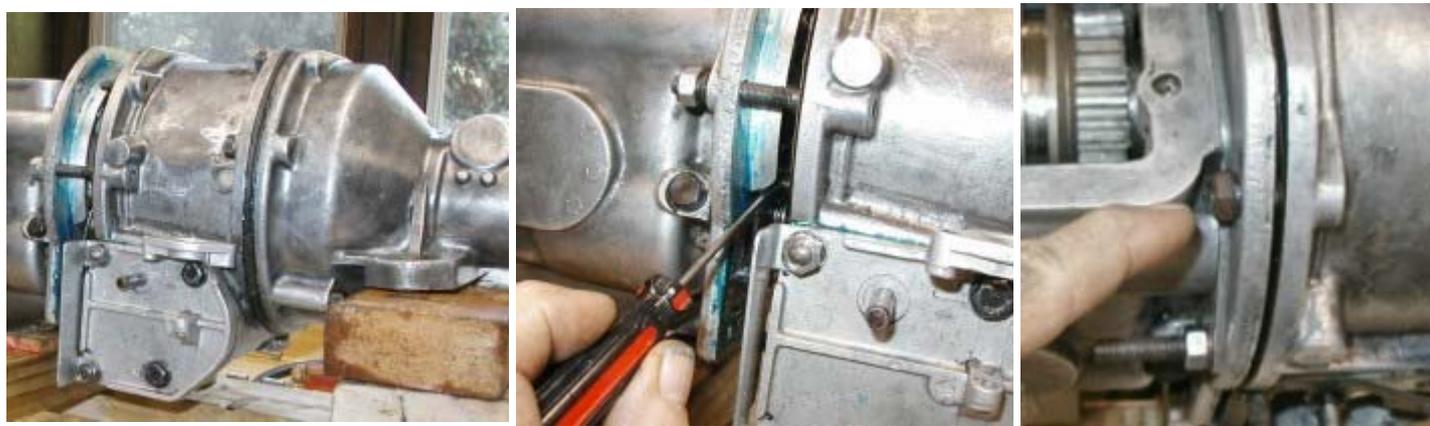
Mating OD to Gearbox: The OD was slid over the gearbox mainshaft and the back end was shored up with blocks as shown in the left photo below. The OD was then pushed toward the gearbox (or as the manuals say, offered up) while rotating the mainshaft back & forth till the splines on the mainshaft mated with the planet carrier and then the unidirectional clutch. Lock washers and nuts were put on the two long studs and used to draw the OD to the gearbox. The nuts were tightened alternately a couple turns each while rotating the mainshaft back & forth. When the mainshaft became hard to turn, both nuts were loosened until the shaft turned freely and then the back of the OD was wiggled --- the other studs seem to bind entering the adaptor plate and wiggling the OD freed them. A very minimum torque was used on these nuts. If the nuts are hard to turn, they should be backed off because something is hung up. Once the OD was closed within an inch or so, a screwdriver was used to push the springs forward and over the nipples on the adaptor plate (center photo below). The OD was then drawn further toward the gearbox until enough of the short studs were protruding so that lock washers and nuts can be screwed on. The top nuts must be screwed on before the OD is against the adaptor plate, there will be insufficient gap at that time to slip the nut over the end of the stud --- see right photo below. The wire holding the pump down was clipped and removed when there was about a 0.1 inch gap between the OD and the adaptor plate. The OD was then pulled to the gearbox by tightening the nuts on the two long studs. Once the OD was against the adaptor plate, the other four nuts were tightened. (Tightening the lower two nuts before the the OD is against the gearbox is one way to bend the adaptor plate.)

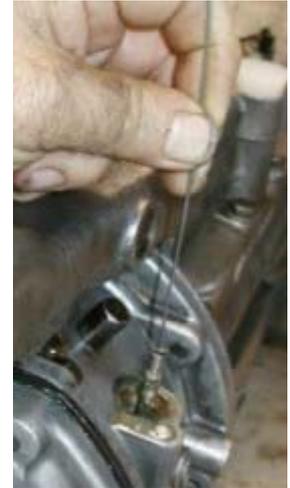
Time to go get a snack while the pressure bled off. Came back a little later ---- no change in pressure. I then loosened the adaptor with gauge carefully. The plan was to loosen it enough so that it would leak and bleed off the pressure that way. It worked and not too much oil escaped, there was still a lot of air mixed in --- the oil was frothy. (The oil was observed to be nearly free of air after more operation indicating that most the air worked out of the fluid). The plug, spring & plunger were then removed. The ball was easily picked out with a magnetic pickup tool. The end of a length of ~19 gauge soft steel wire was bent slightly and then pushed into the end of the valve spindle then pulled up --- the spindle come out easily (photo on right). The top of the spindle was cleaned and blown into --- no air passage. --- it was plugged. A suitable drill bit was slid down the inside of the spindle and turned a few times then removed and wiped on a clean paper towel. Didn't see anything in the fluid but it had a lot of air mixed in it and not sure if I would have been able to see anything anyway. This time when the top was blown into, the passage was clear. (This left an after taste nearly as bad as beets.) The spindle was then cleaned thoroughly and reinstalled: everything worked fine then.

So, where did the dirt come from? It was probably in some of the internal passages in the main casting. Recall that this OD had a major internal failure and it is quite possible part of the debris got in the passages during the cleaning process. It appeared that little made it pass the screen, so if it was exercised a bit, hopefully anything else will work itself through the system, and no problems will be encountered in the future.

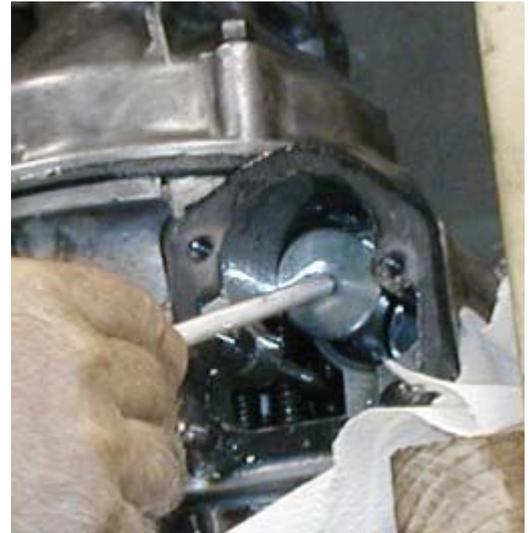
The pressure was at about 310 psi and needed to get to be 450psi, so needed an increase of 140psi. Decided to try two washers behind the spring. Turned the gearbox on the front to let oil drain out of the OD (this is a test that needed to be run anyway to see if front seal leaked -- it didn't - yet). The cover plate was removed (nuts on studs first, then the bolts beside the spring, slackeden together). **Caution, operate and release the operating valve using the lever or solenoid a half dozen times to relieve the pressure before removing the cover plate.** Then put in two washers (photo on right), put it back together and fired it up. Pressure went to about 360 --- about 25 psi increase per washer. The washers were 1/16 inch thick just like the one Ronnie used, but this is a different type accumulator and spring.

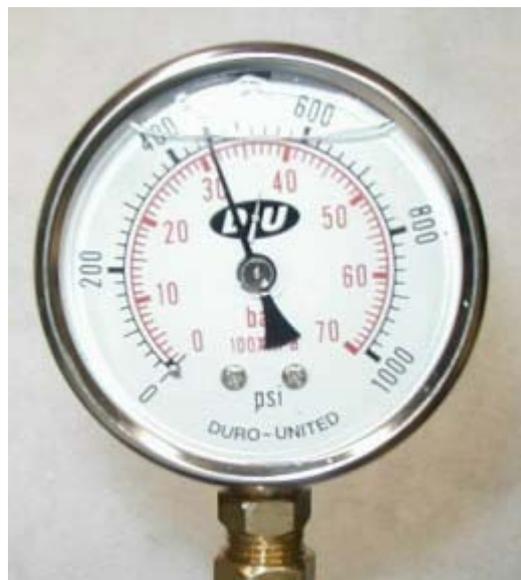
The new gauge is pictured on right. Notice the liquid level. The needle was steady on this one, what a difference!

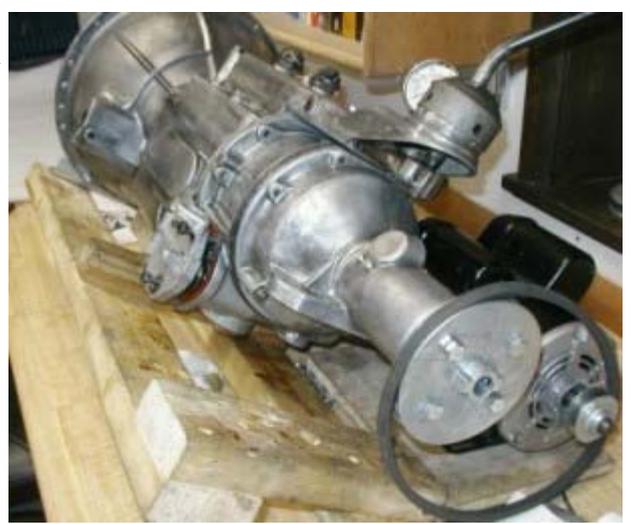
More Accumulator Pressure Measurements: With a new gauge and a stack of accumulator springs, I first tried that new outer spring with the original inner spring and found the pressure to be 360 psi. That was still a little low, but 450 psi looked reachable with a couple packing washers. I had a bunch of questions about what if "this spring" was used or "that spring combination" so I made out a list of things to test and set about the task. I got pretty efficient changing the springs ---- about three minutes by tilting the unit up part way on it's side so the oil wouldn't leak out as shown in photo on right. The dust shield and the nut on the top stud were left off. The solenoid and actuating lever were not used during these tests.

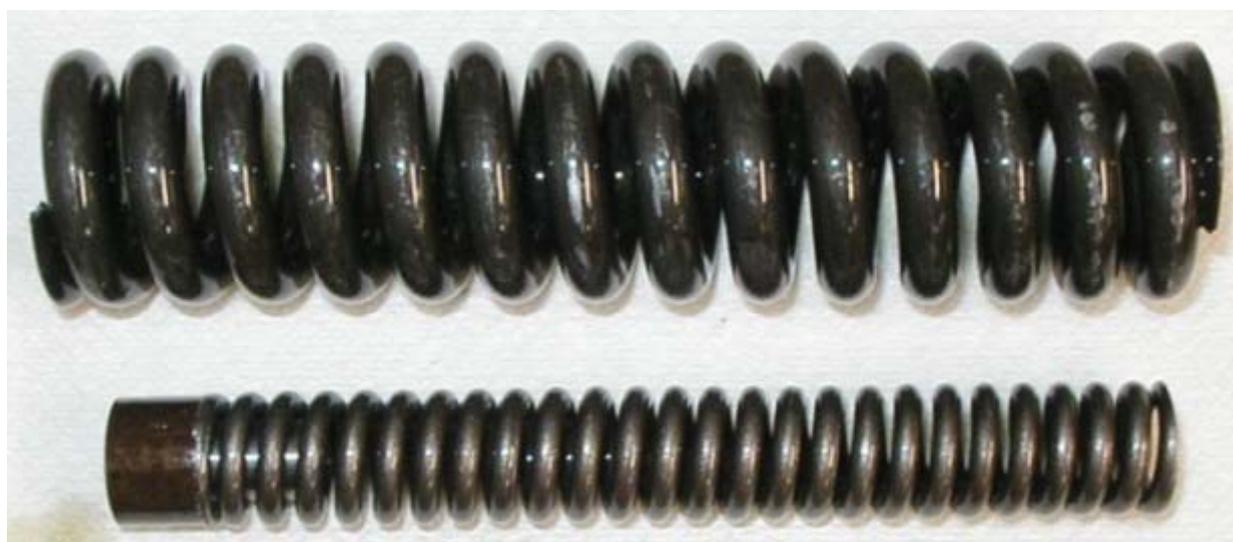
Test	Spring Configuration	Pressure (psi)
1	Early Accumulator Outer Spring (original)	250
2	Early Accumulator Outer Spring (original) + Late accumulator spring (used)	455
3	Early Accumulator Outer Spring (original) + Late accumulator spring (new)	515
4	Early Accumulator Outer Spring (new)	350
5	Early Accumulator Outer Spring (new) + Early Accumulator Inner Spring (original)	360
6	Early Accumulator Outer Spring (new) + Early Accumulator Inner Spring (original) + 0.9 inch Plug	415
7	Early Accumulator Outer Spring (new) + Early Accumulator Inner Spring (original) + 0.9 inch Plug + 1 Washer	440
8	Early Accumulator Outer Spring (new) + Early Accumulator Inner Spring (original) + 0.9 inch Plug + 2 Washers	465
9	Early Accumulator Outer Spring (new) + Early Accumulator Inner Spring (original) + 0.9 inch Plug + 3 Washers	485
10	Early Accumulator Outer Spring (new) + Early Accumulator Inner Spring (original) + 0.9 inch Plug + 4 Washers	510

11	Early Accumulator Outer Spring (new) + Early Accumulator Inner Spring (original) + 0.5 inch Plug	380

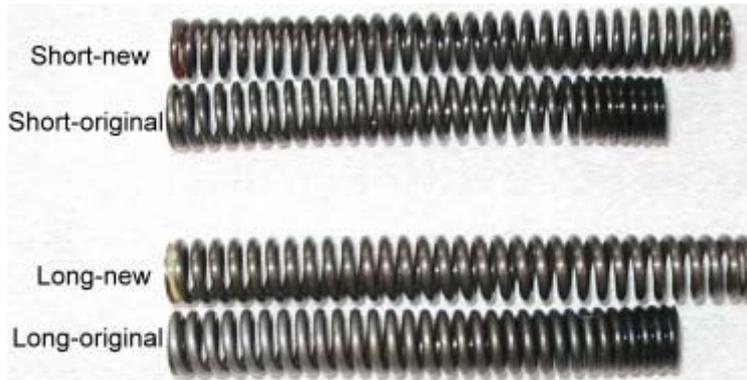
The photo above shows the original and new springs together. The ends of the new springs are painted, red on the short ones and yellow on the long ones. All the springs had about 31.5 turns. Note that the new short springs were wound in the opposite direction from the others --- doubt that the winding direction was part of the original specification. The right 3/4 inch or so of the original springs were clearly collapsed. All of them were that way and they were pretty uniform, so much so that I thought they were manufactured that way. Recall that the release bearing had failed on this unit and these springs pressed the thrust ring into the rotating clutch sliding member. The thrust ring and sliding member got very hot. It was then concluded that the ends of these springs also got very hot, hot enough to remove the temper and allow the springs to collapse. And here I was thinking the PO had substituted the wrong springs. Shame!

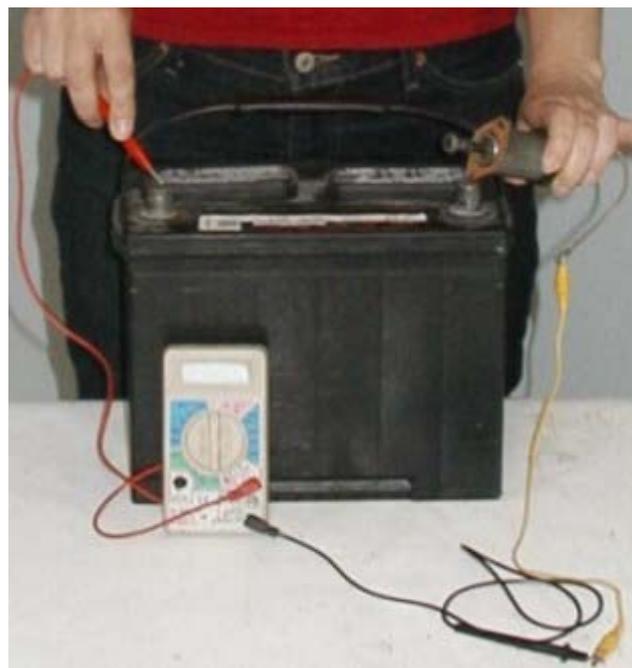
The engineer set the multimeter to the 20 ampere current range and connected the negative (black) probe to the solenoid lead using the yellow clip lead. The positive (red) probe was held against positive battery terminal and the solenoid case was touched against the negative battery terminal. The first test was made with the plunger removed. We read 16 amperes on one and 17 amperes on a second solenoid. Next, she measured the current with a plunger in the solenoid. When the current was applied this time, the plunger snapped into the solenoid and the current read about one ampere, just as it should. She explained that with the plunger in the solenoid, the initial current is about 17 amperes until the plunger reaches the back of the recess and operates a switch to remove the high current pull-in coil and leave only the low current holding coil in the circuit. She must have checked out the schematic at the end of Part I.

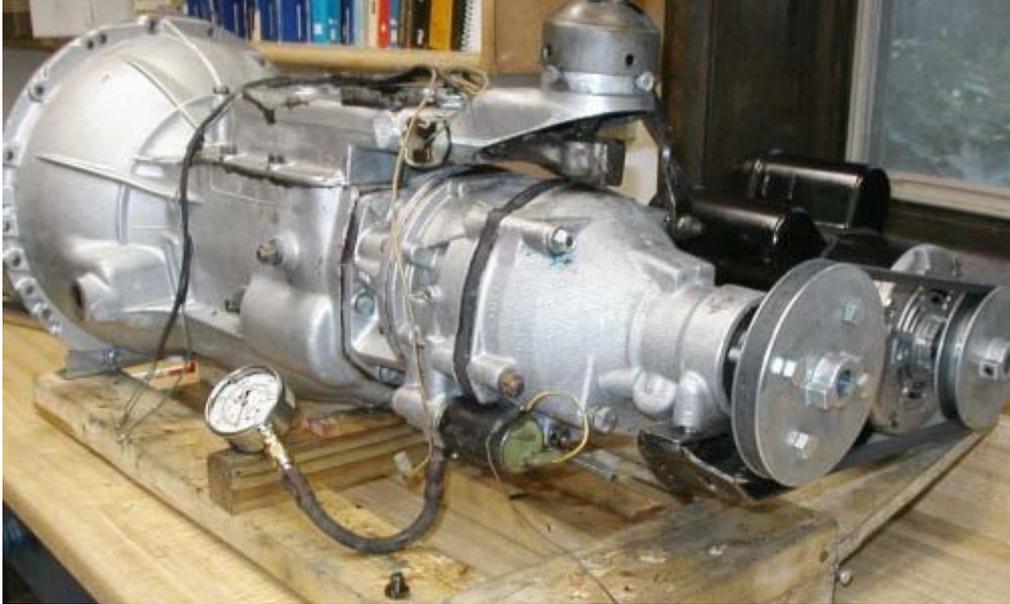
J Type OD: The J type OD from my '76TR6 was put in the test stand to find a small leak. Before firing it up, a small leak from the countershaft cover plate in the front was noted, but it hadn't yet made it to the drain hole; the cover plate was bowed so it was reversed. The rear seal was replaced (again) because there was a one drop drip on the bottom. The motor was then run for an hour. There was a stream of oil from one of the studs near the top that hold the front and rear casting on each side of the brake ring. There is a copper washer then lock washer and then nut on the stud. The lock washer had distorted the copper washer. The fix was to replace the copper washers on the two top studs and then add a flat washer between copper washer and lock washer. Joint sealer was also used around the stud.

While the unit was on the bench the hydraulic pressure was measured. The gauge was attached to a hole just to the front of the solenoid. The plug for the hole is setting beside the hose in the photo. The hole threads are 3/8-16. An old rear brake hose from a TR6 was used to connect the gauge. One end was threaded 3/8-24. A 3/8-16 die was run right over the old threads -- worked great. The other end had an inch or so length of 1/2 inch cylinder and then the smaller part threaded 3/8-24. The threaded part was cut off and the larger section was then turned down to 3/8 inch and threaded 1/8 inch pipe threads which then screwed into the reducer on the end of the gauge. (While doing this it was observed that the 1/8 inch pipe thread is nearly identical to the 3/8-24 piece cut off, except the pipe thread is slightly tapered. In hindsight, the 3/8-24 will probably mate with the 1/8 inch pipe thread in the reducer if a couple layers of Teflon joint tape are used.) The pressure was 450 psi at 1300 rpm and 460 psi at 2600 rpm. (The solenoid must be operated to record any pressure; this system has no accumulator.) The specs call for 460 psi to 490 psi. The pressure relief spring was probably a little weak due to age, but this was close enough.

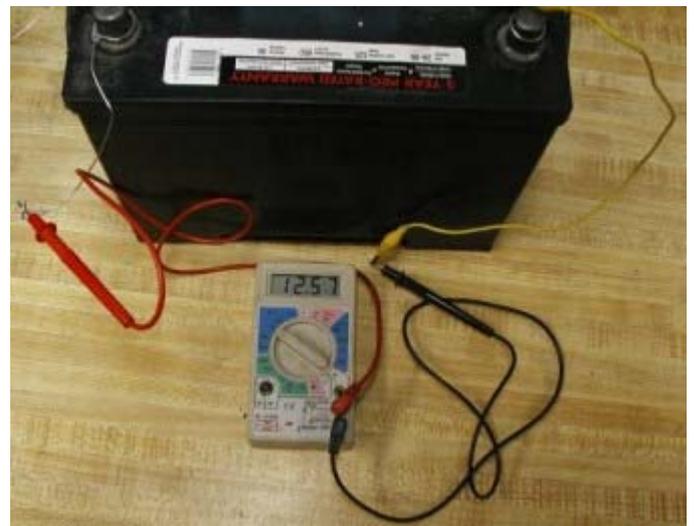
Multimeter: A test instrument is required to troubleshoot the OD electrical circuit and other Lucas mysteries. I prefer an inexpensive multimeter as shown in photo. Several of these were purchased for less than \$5 each at the electrical market in Bangalore, India several years ago; just couldn't pass up the bargain. A package of clip leads (Radio Shack) like the yellow one in the photo are also very useful.

For all the tests except the solenoid current test, the meter is set to a DC voltage scale greater than 14 volts. This one had a 20 volt scale, others may have a 15 volt scale. The black lead is connected to the common or ground terminal on the meter and the red lead is connected to the red voltage-current-resistance terminal on the meter.

Test for 12 volts: To test for 12 volts at a point in a circuit, one end of a clip lead is connected to the to the black meter lead and the other end of the lead to electrical ground. For these tests, the braided cable on the negative battery terminal makes a good ground connection. The probe at the end of the red lead is held against a terminal to see if 12 volts is present. The positive battery terminal should be checked first to verify that there is a good connection to ground, the meter is turned on, and the battery is charged. The battery should read a little over 12 volts --- 12.57 volts for the battery in the photo above.

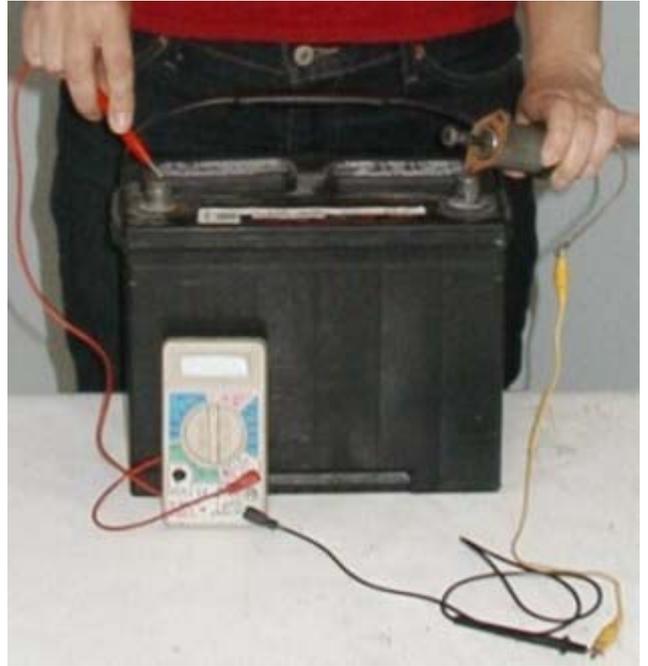
The solenoid should draw 15 to 20 amperes with the plunger removed (this is done for only a few seconds, the solenoid is not designed to carry this current continuously). The current drain should be about 1 ampere with the plunger in place. The multimeter is set to the 20 ampere current range for this test (the red lead is moved to the high current terminal). The negative (black) probe is connected to the solenoid lead using the yellow clip lead and the positive (red) probe is held against positive battery terminal and the solenoid case is touched against the negative battery terminal.

The first test is made with the plunger removed and should read 15 to 20 amperes. Next, the current is measured with a plunger in the solenoid. When the current is applied this time, the plunger should snap the solenoid and the current should read about one ampere; the initial current is 15 to 20 amperes until the plunger reaches the back of the recess and operates a switch to remove the high current pull-in coil and leave only the low current holding coil in the circuit. If the meter reads no current, the solenoid coils are likely open.

If the solenoid has an open or short, I remove the top cover and see if there is a problem with the internal switch that I can possibly repair.

If the solenoid can't be made to pass this test, it should be replaced.
